# Natimuk Flood Investigation Study Report

Project Name	Natimuk Flood Investigation
Client	Wimmera CMA
Client Project Manager	Paul Fennell
Water Technology Project Manager	Ben Hughes
Report Authors	Ben Hughes
Job Number	2120-01
Report Number	R06v02
Document Name	2120-01R06v03.doc

Following the December 2010 and January 2011 flood events, Water Technology was commissioned by the Wimmera CMA to undertake the Natimuk Flood Investigation. This included detailed hydrological and hydraulic modelling of Natimuk Creek and Little Natimuk Creek, flood mapping of the Natimuk township area, flood mapping of the entire upstream catchment, and also provided recommendations for flood mitigation works.

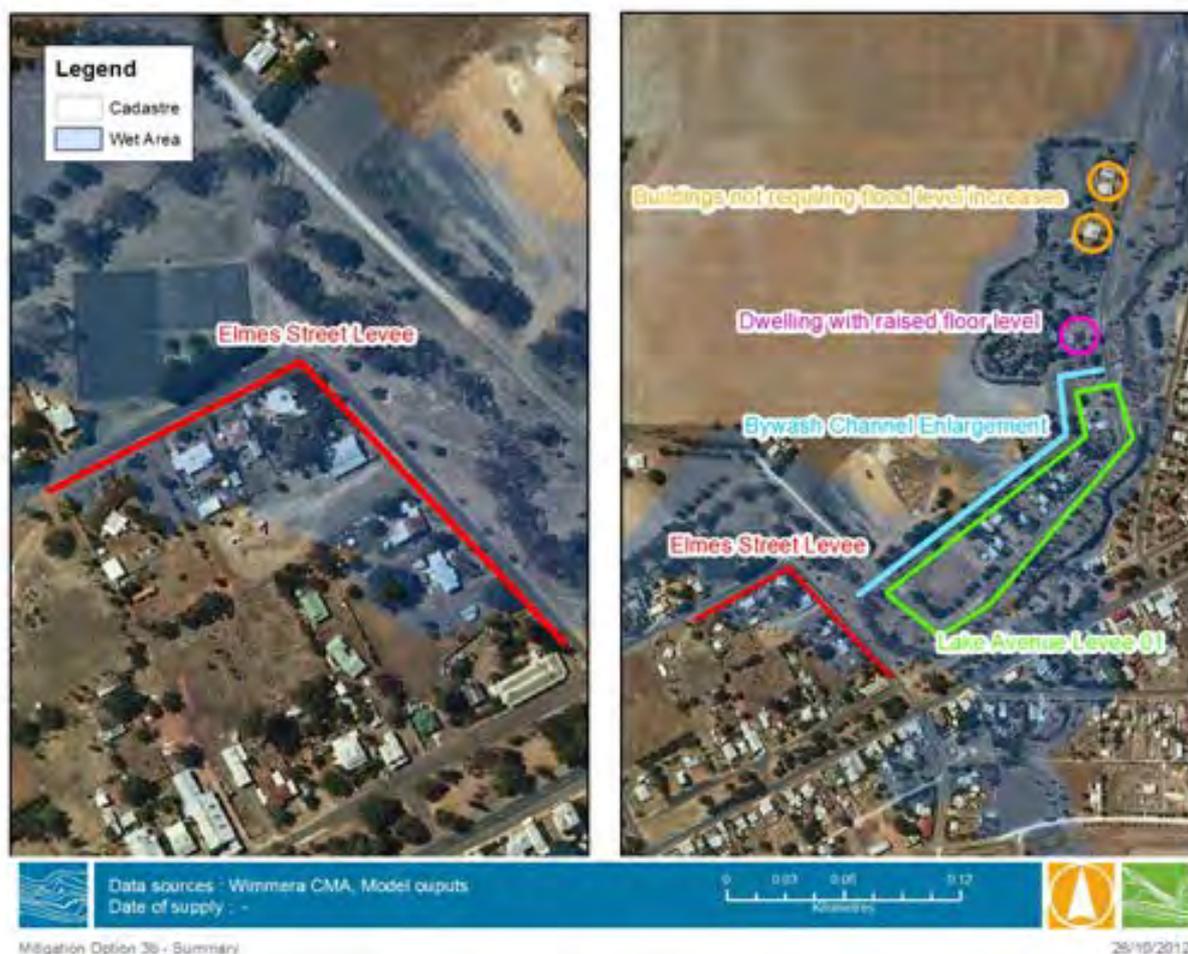
A figure summarising these two options is shown below.

A benefit cost analysis was undertaken to assess the economic viability of the two mitigation options. Indicative benefit cost ratios were based on the construction cost estimates and Average Annual Damages calculated. The benefit cost analysis for each option is shown below with comparison to the existing conditions.

The Elmes Street Levee is a far more feasible than the Combined Mitigation Option 03b. The combined option does protect a much larger number of houses but the cost of its construction and maintenance far exceeds the potential annual damage savings

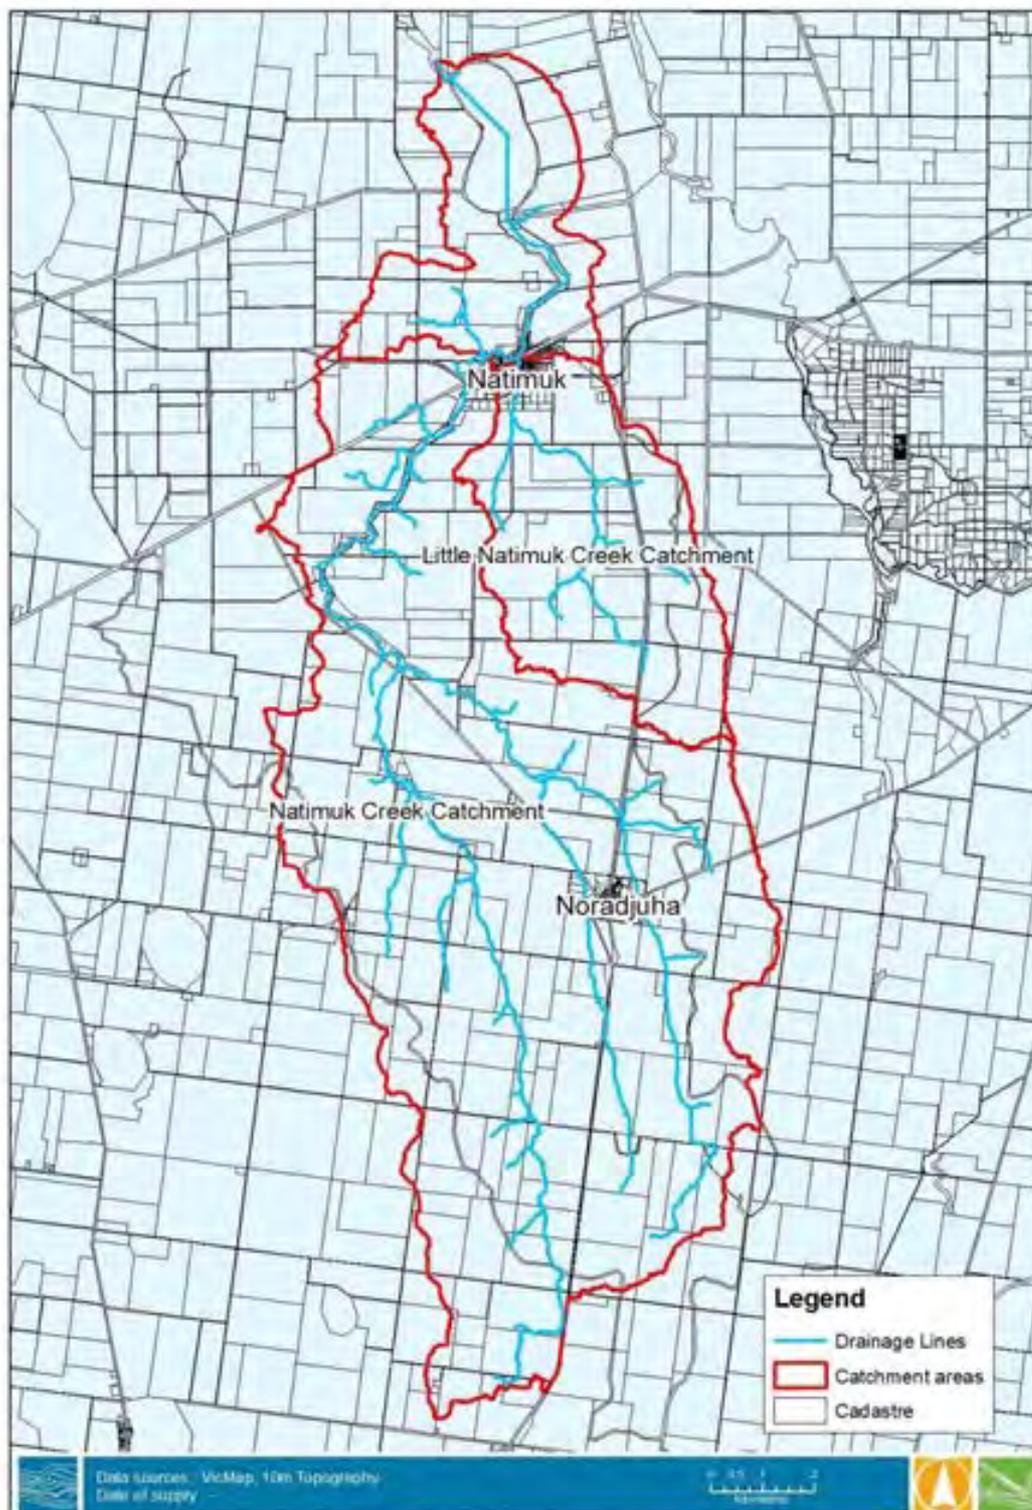
Figure 1-1 Natimuk Creek and Little Natimuk Creek catchment

Both Natimuk Creek and Little Natimuk Creek are ephemeral. Both have no available streamflow information upstream of the township, with minimal information available for Natimuk Creek at Natimuk Lake, consisting only of a water quality gauge with nine spot level readings across April 2006 to October 2007.

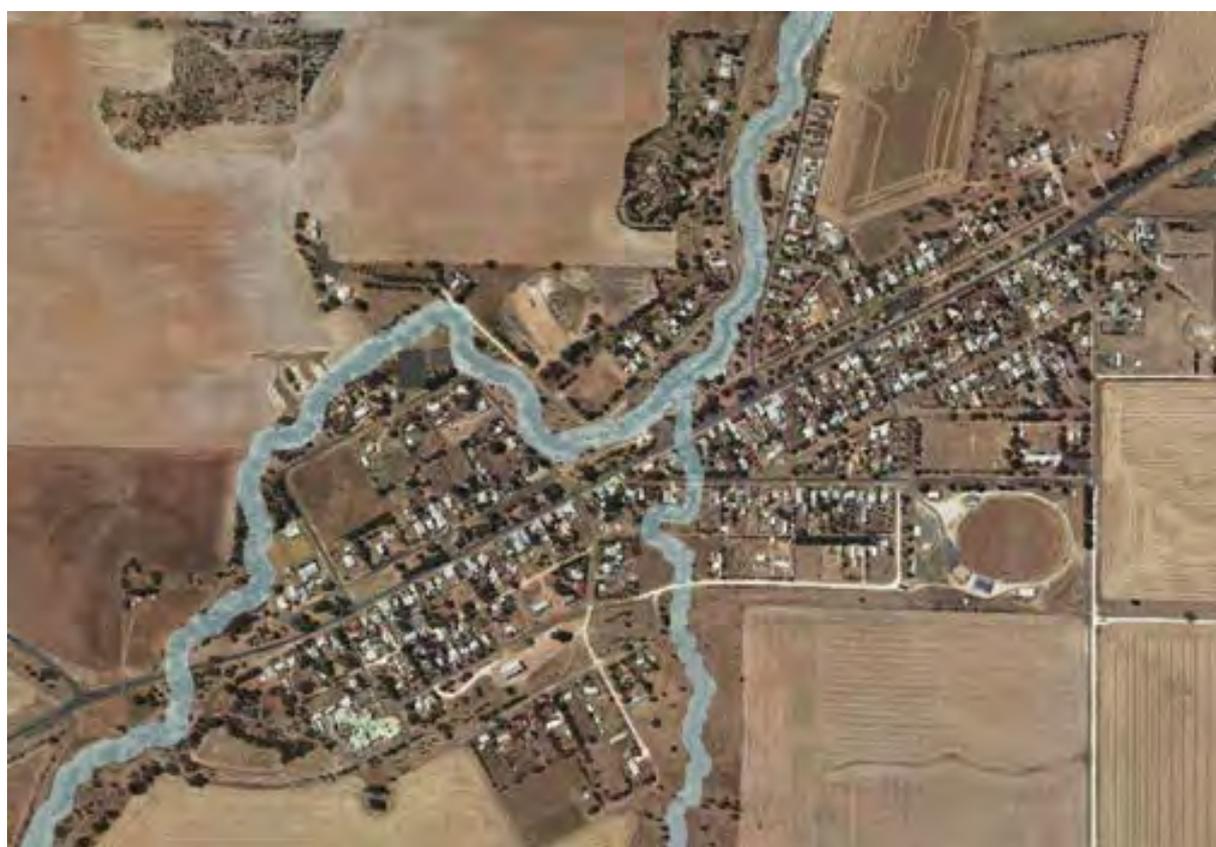
**Figure 2-1** Current Land Subject to Inundation Overlay for Natimuk

Natimuk Creek and Little Natimuk Creek through Natimuk are currently covered by a Land Subject to Inundation Overlay (LSIO) within the Horsham Rural City Council planning scheme. This overlay was developed based on geological mapping and orthophotos, as shown below in Figure 2-1. The January 2011 flooding resulted in a significantly greater extent of inundation than that of the LSIO.

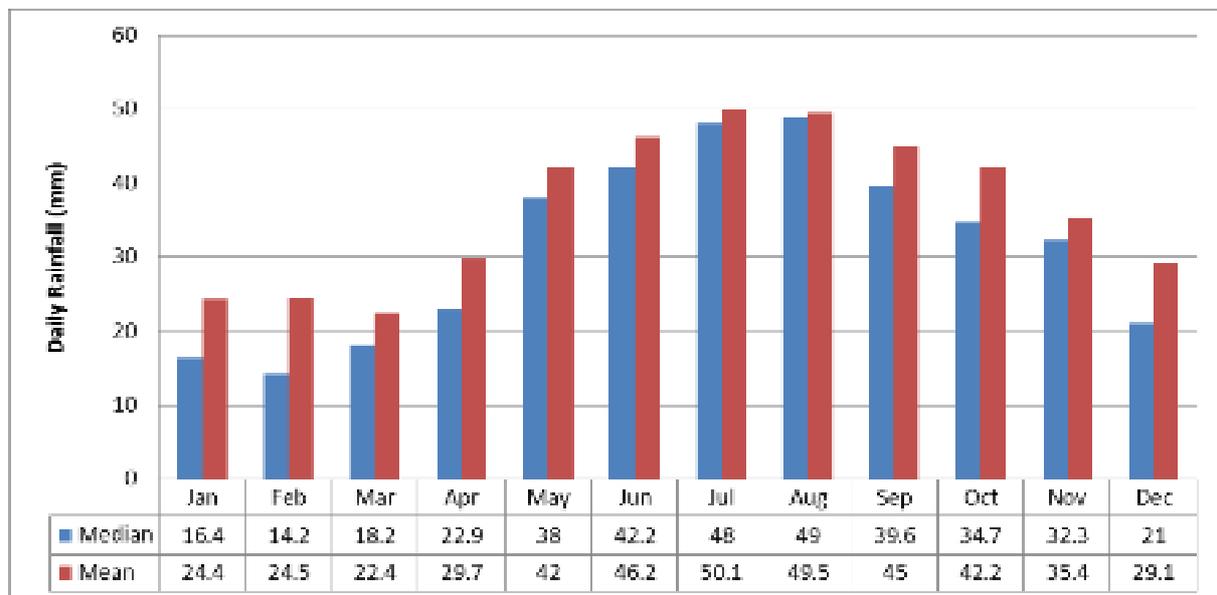
Figure 2-2 BOM historical rainfall records for the Natimuk Rainfall gauge (BOM, 2011)

Figure 2-2 below shows the mean and median monthly rainfall totals for the entire length of record at the Natimuk rainfall gauge. The wettest months are largely in winter with June, July and August recording the highest mean values. The large difference between the mean and median monthly rainfall totals is an indication of the occurrence of extreme events, as they will statistically have a greater impact on the mean than the median. Larger differences between the mean and median monthly rainfalls are observed in the months of December, January and February, indicating those months have witnessed a greater proportion of extreme events.

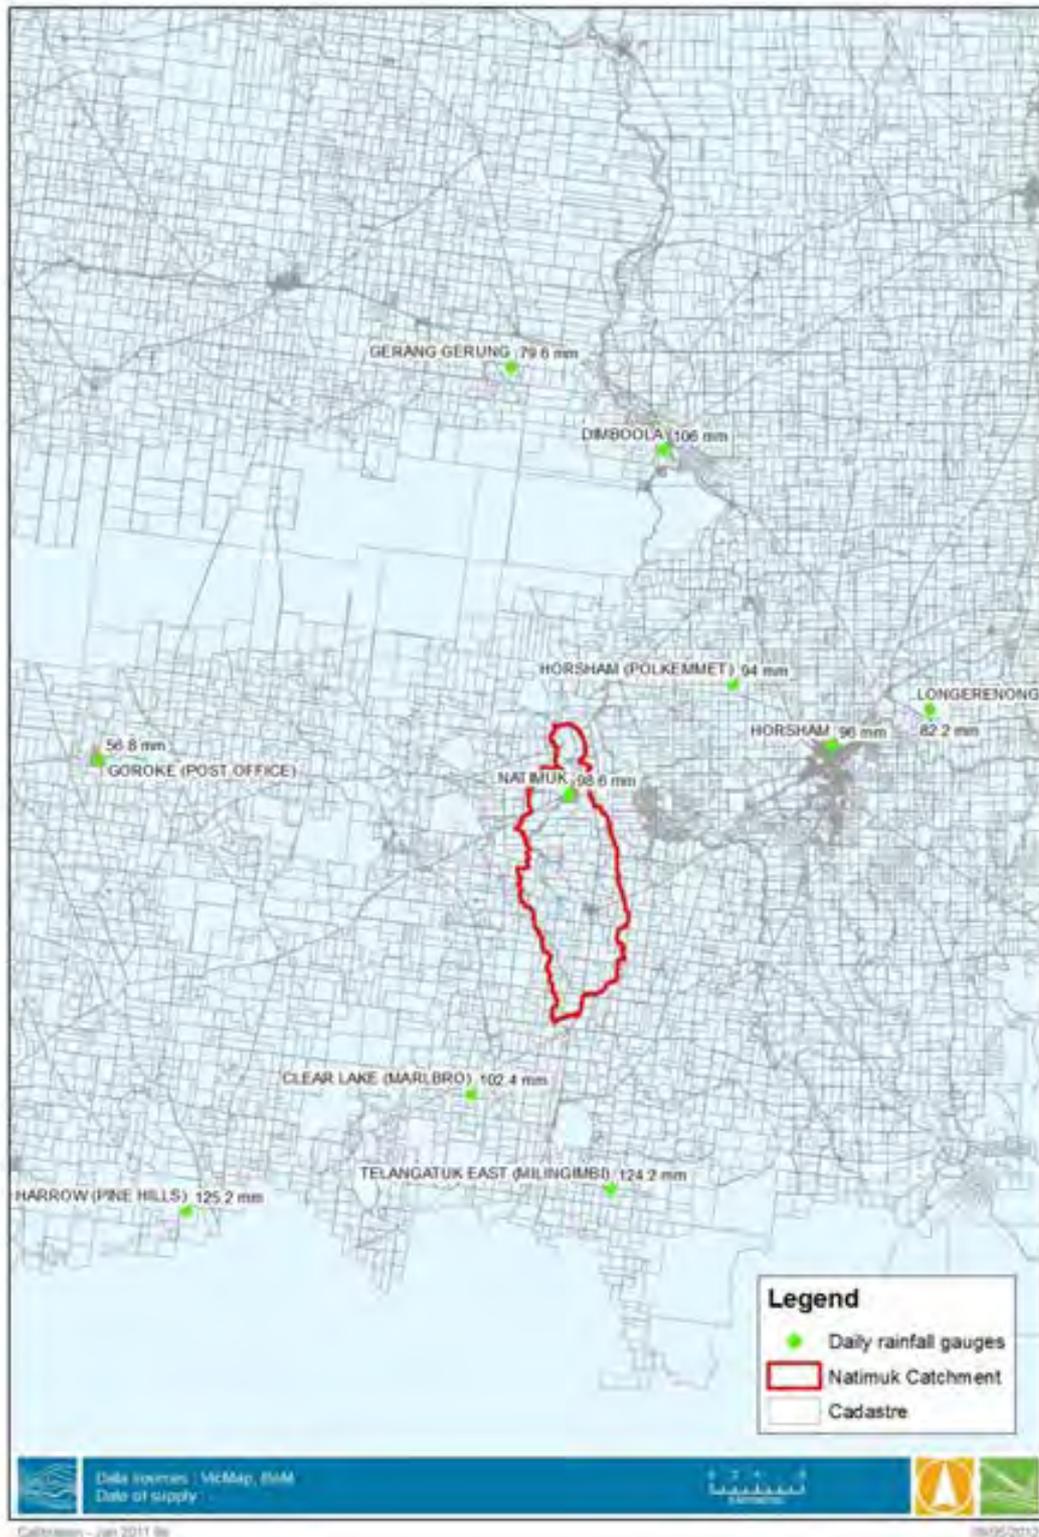
Figure 2-3 December 2010 rainfall totals (cumulative 3 day total to 9am 8<sup>th</sup> December 2010)

Over a three day period up to 9am on the 8<sup>th</sup> of December 2010, between 56 and 125 mm of rainfall was recorded at surrounding gauges. A distribution of rainfall depths over the 3 day period is shown in Figure 2-3.

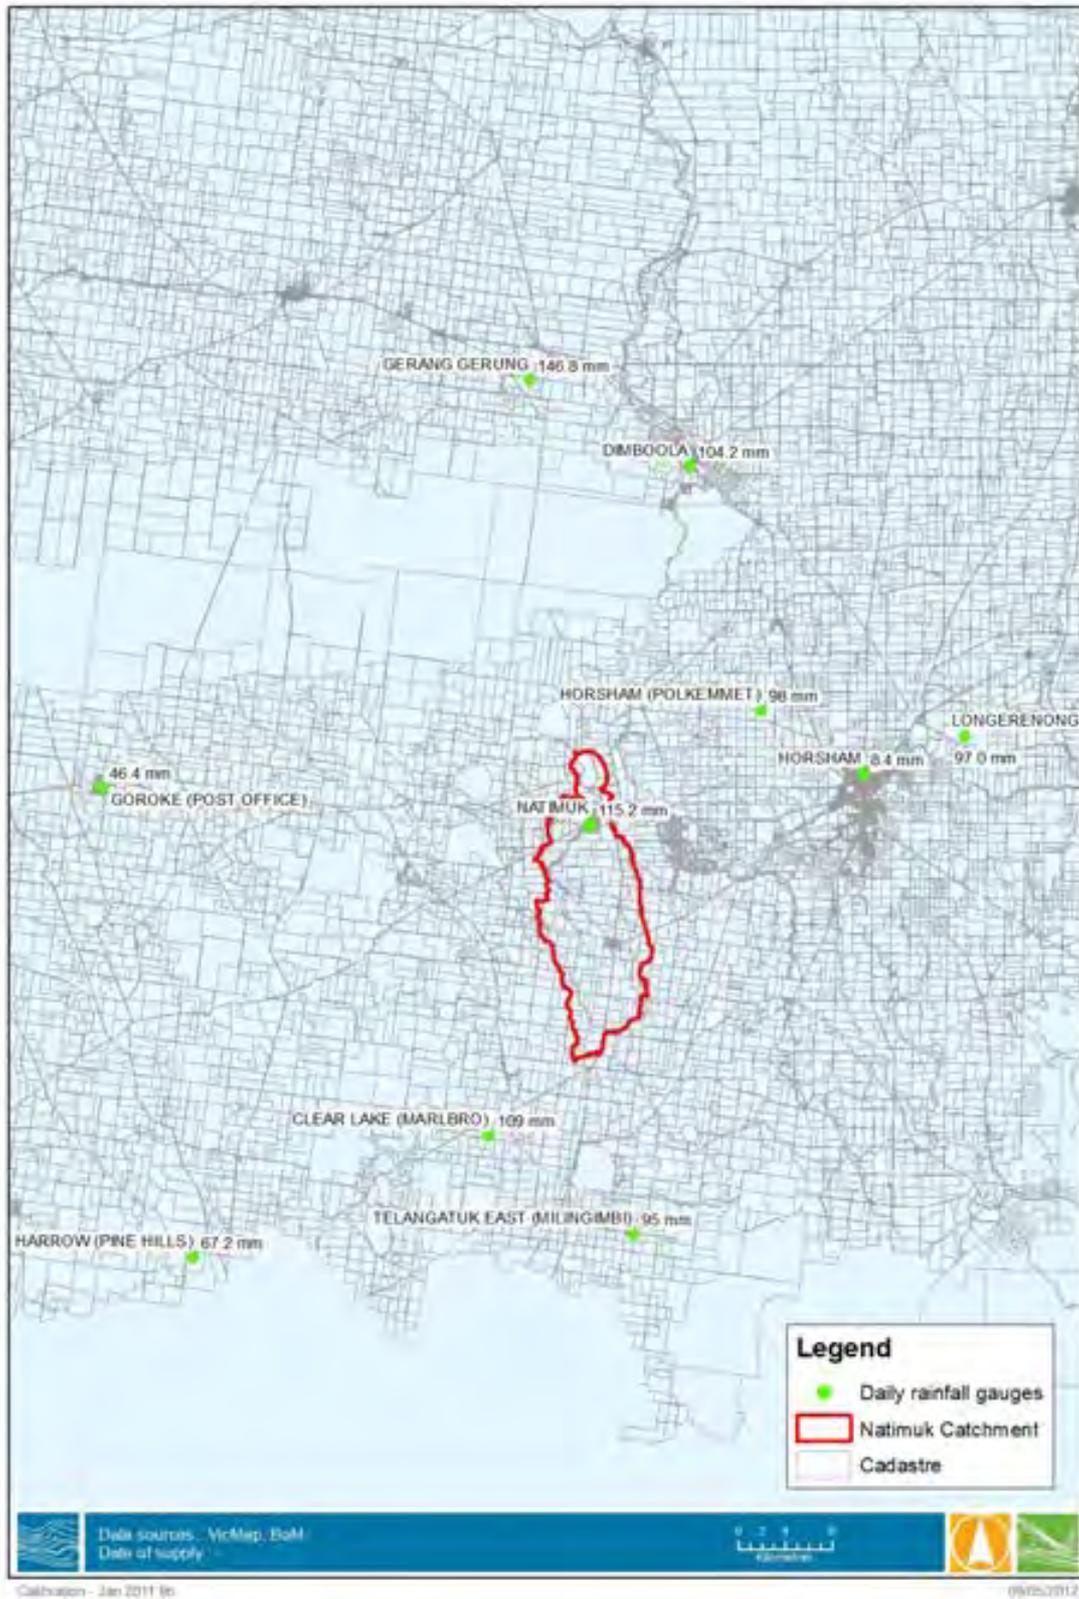
Figure 2-4 January 2011 rainfall totals (cumulative 3 day total to 9am 8<sup>th</sup> December 2010)

The January 2011 rainfall event was widespread with record rainfall totals falling across Victoria. Heavy rainfall began on Tuesday 11<sup>th</sup> January 2011 at around 10 pm. The Horsham pluviograph indicated the highest intensity rainfall occurred at 6.26am Wednesday morning. Record daily rainfall totals were recorded at the Horsham (Polkemmet Rd), Clear Lake, Telangatuk East (Milingimbi), Kanagulka and Horsham (Aerodrome) gauges. Natimuk experienced high rainfalls in the 24 hours prior to 9am on the 12<sup>th</sup> and 14<sup>th</sup> of January. Figure 2-4 shows the daily totals recorded at 9am on the 12<sup>th</sup> of January 2011.

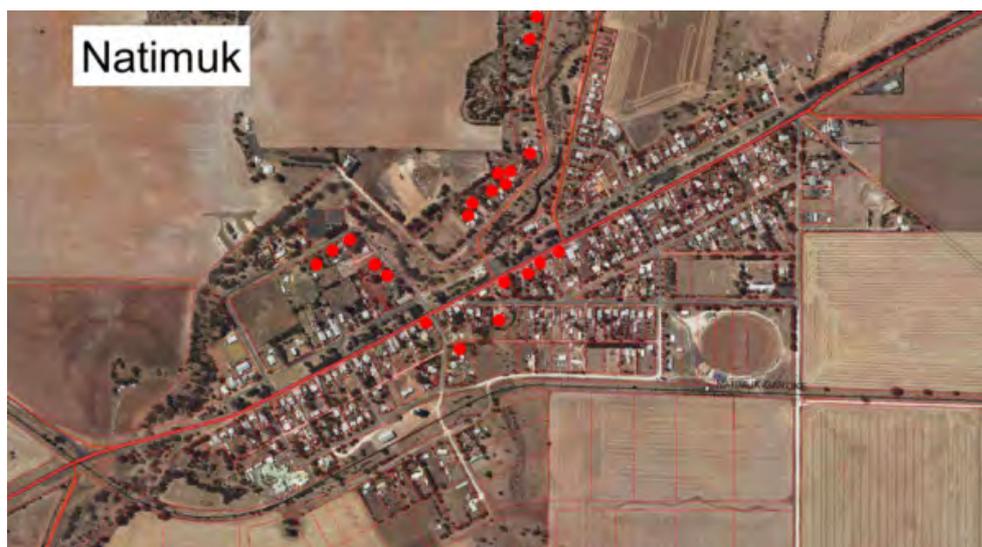
**Figure 2-5 Natimuk township, showing properties flooded above floor (Wimmera CMA)<sup>3</sup>**

Natimuk Creek began to flood around 7am on Wednesday 12<sup>th</sup> January; around 9 hours after rainfall began. Water levels continued to rise and peaked at approximately 2pm, after which they began to recede. Twelve homes were evacuated during the event with a total of 21 buildings were reported to be inundated above floor level within the township<sup>3</sup>, since this initial assessment residents have highlighted some buildings were inundated below floor level with sheds on the property inundated above floor. The flood-affected properties were located in Lake Avenue, Elmes St, Wimmera Highway, Depot Lane and Jory Street. Figure 2-5 below shows an aerial view of Natimuk with the flood affected properties originally identified. Figure 2-6 shows an aerial photo of the flooding at Natimuk taken on Wednesday 12<sup>th</sup> January at 11.05am.

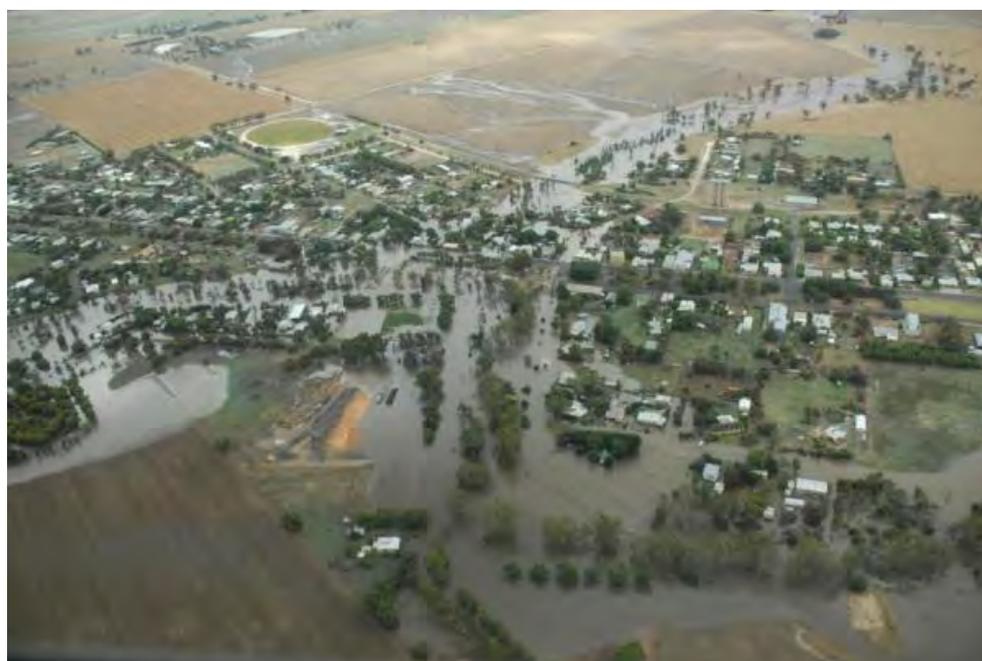
**Figure 2-6 Flooding though Natimuk taken on Wednesday the 12<sup>th</sup> of January at 11.05am (Wimmera CMA)**

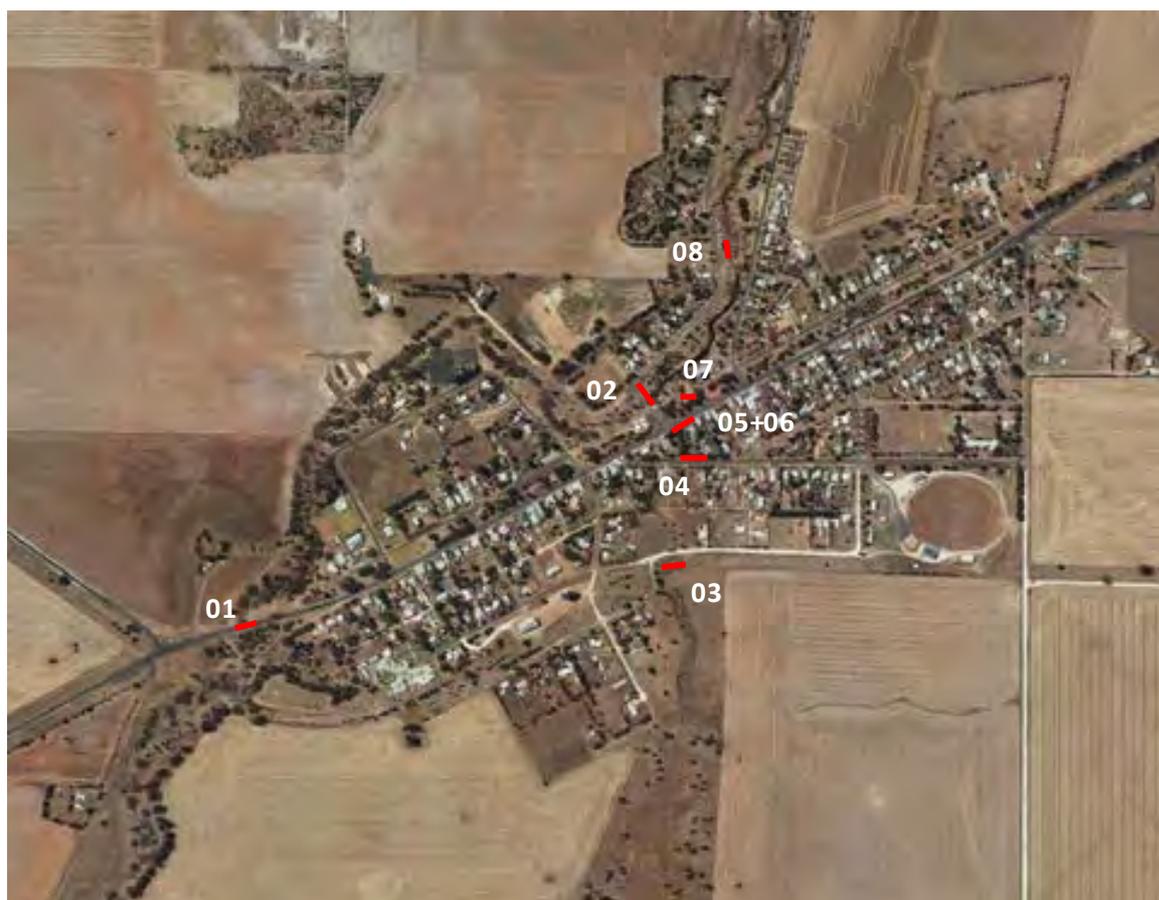
Figure 2-7 Key hydraulic structures through Natimuk

Key hydraulic structure information along Natimuk Creek and Little Natimuk Creek was required for input into the hydraulic model. Some information on these structures was provided by VicRoads and the Horsham Rural City Council. Others were unavailable and were surveyed. Figure 2-7 shows the location of the key waterway structures in the Natimuk township. Table 2-1 shows the details of the structures, and source of the data. Field survey was also required to confirm the reliability of LiDAR data.

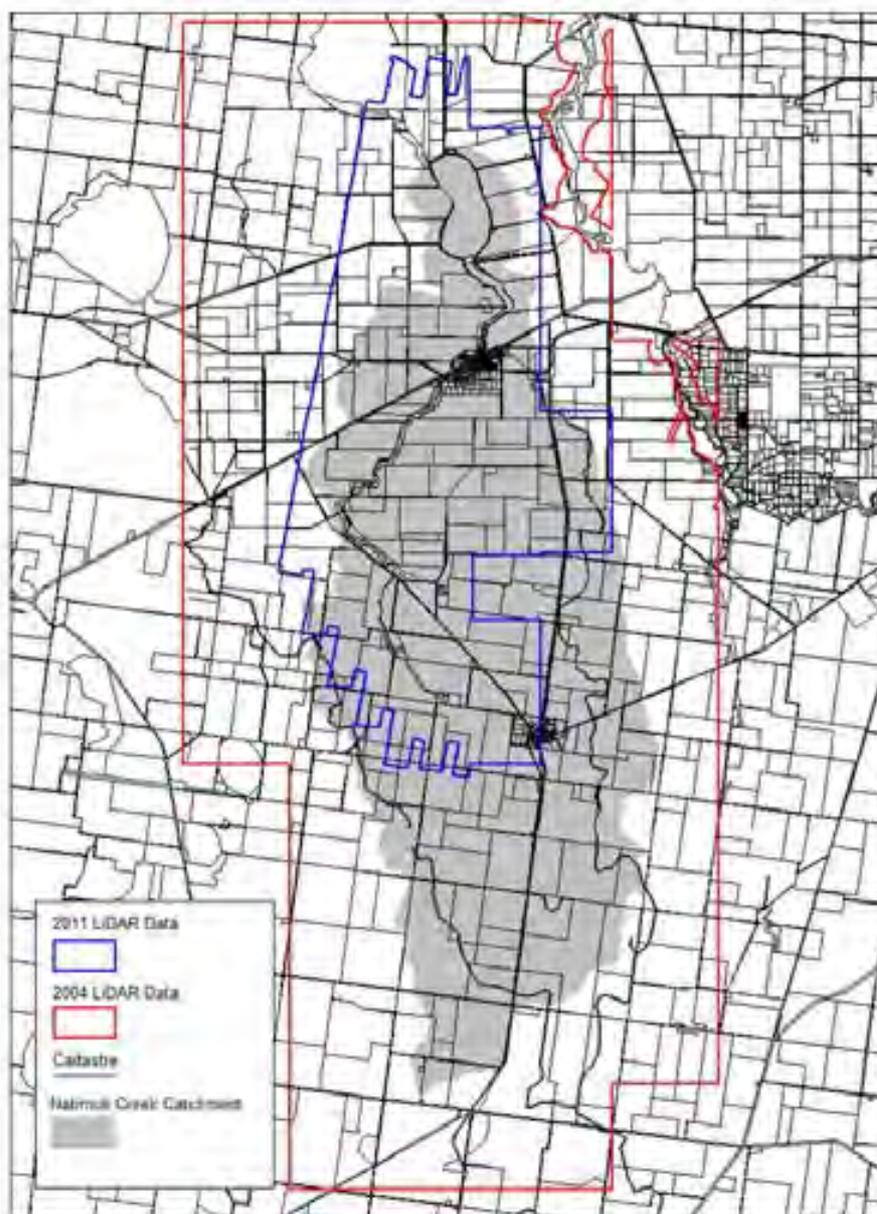
**Figure 2-8 2004 and 2011 LiDAR data coverage**

2011 LiDAR	2004 LiDAR
<b>Vertical Accuracy</b>	± 0.10m (68% Conf.) on bare earth	± 0.15m to 1 sigma
<b>Average horizontal point spacing</b>	1.8 pts/m	2.5m
<b>Coverage</b>	Parts of the Wimmera River, Natimuk Creek, Mackenzie River, Norton Creek, Dumunkle Creek, Wattle Creek, Howard Creek, Concongella Creek, floodplain near Natimuk Horsham, Navarre, Landsborough and Rupanyup	WCMA extent, excluding the Wimmera River floodplain (Jeparit to Glenorchy), Yarriambiack Creek Floodplain surrounding Warracknabeal

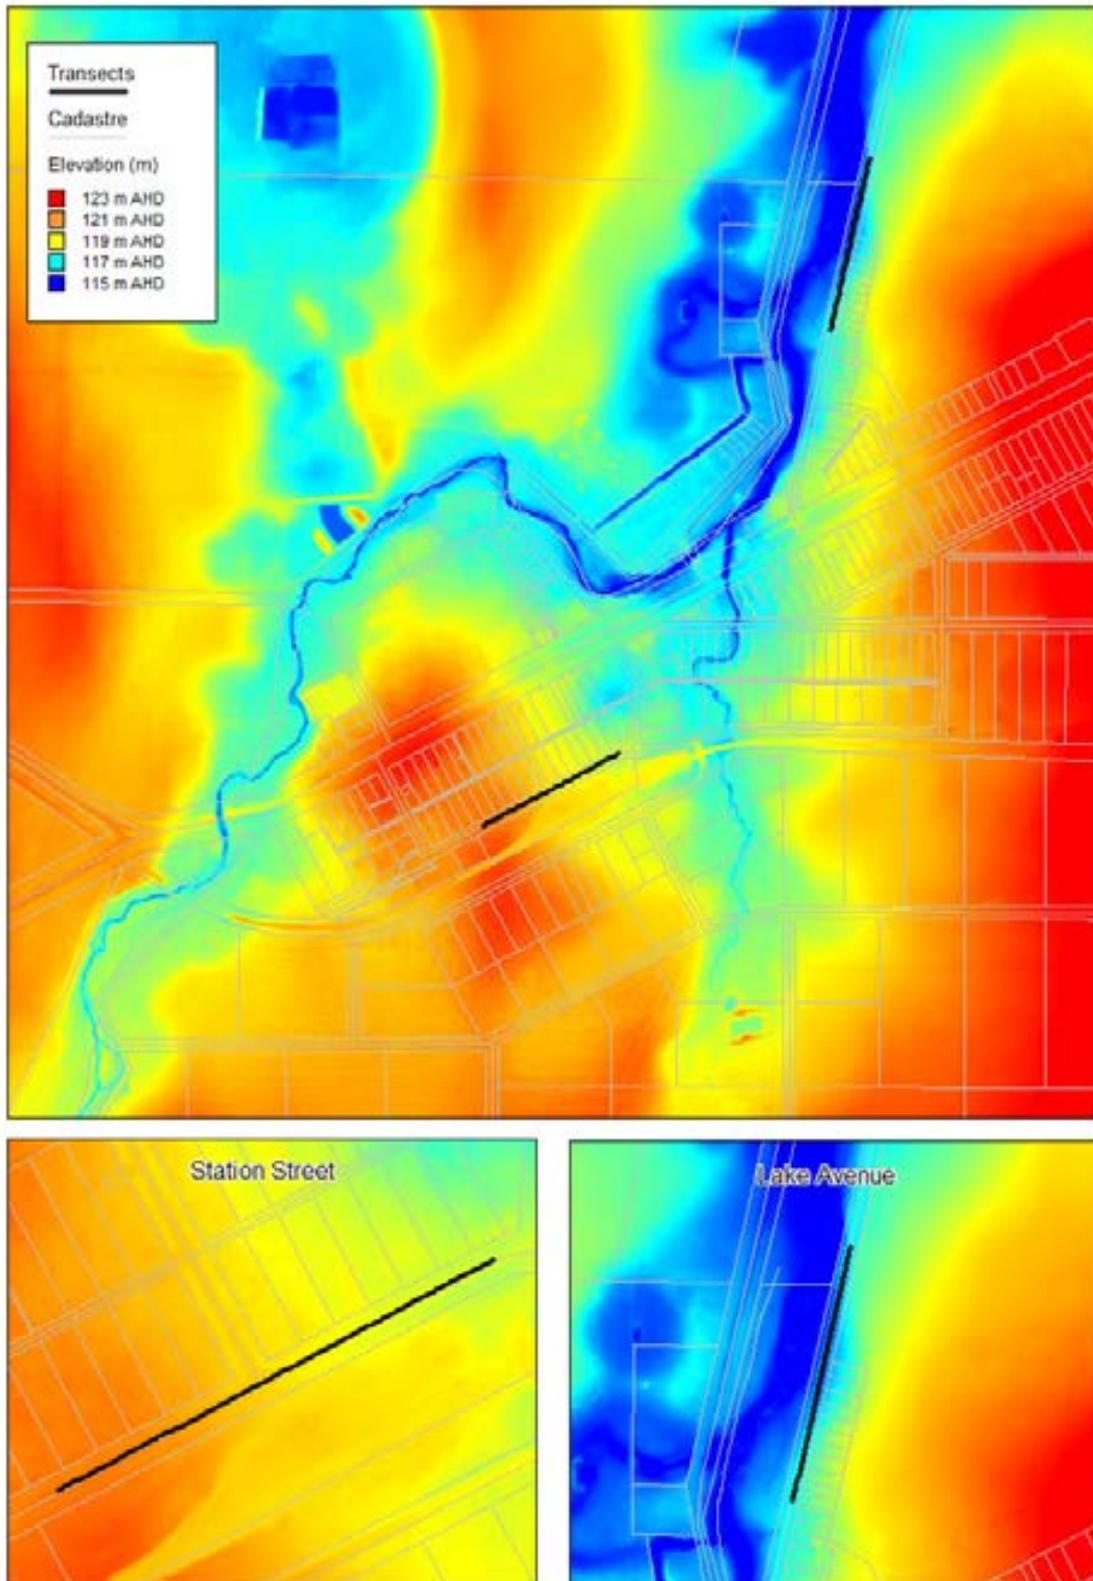
Figure 2-9 Locations of surveyed transects

A comparison of the two LiDAR data sets and field survey was undertaken to ensure the different survey datasets were consistent. Two transects were surveyed along Station Street and Lake Avenue. These roads were chosen as they are relatively flat and have no camber. The LiDAR was then compared to the two surveyed transects. Figure 2-9 shows the locations of comparison. The extracted transects are shown below in Figure 2-10 and Figure 2-11.

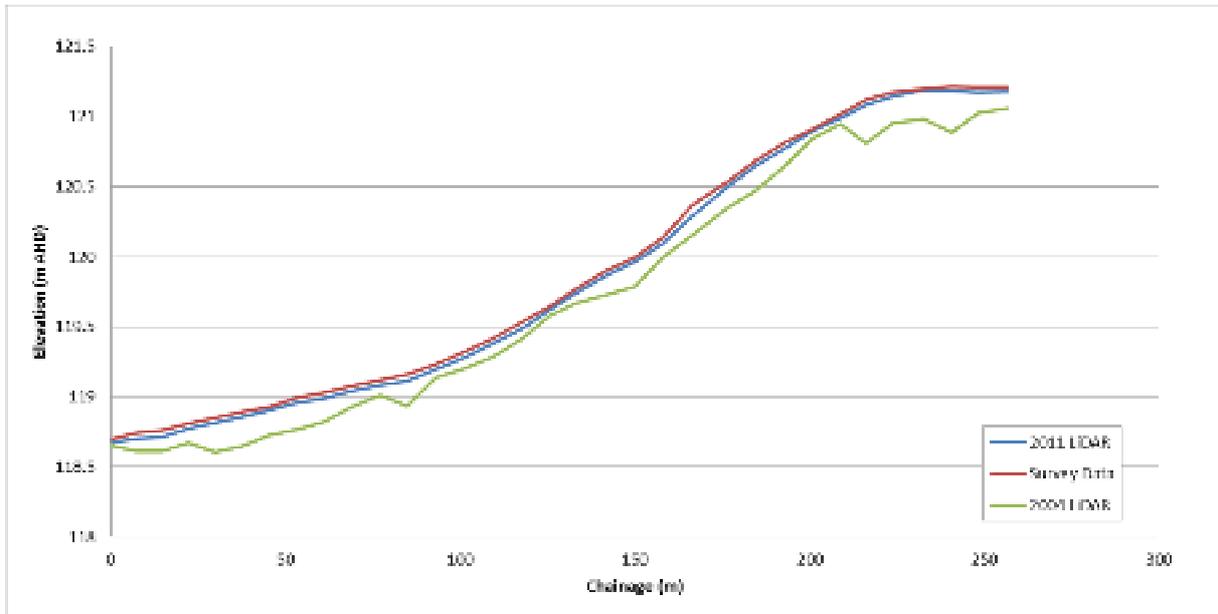
**Figure 2-11 Station Street survey comparison transect**

In both comparison transects the 2011 and 2004 LiDAR data was slightly lower than the surveyed data. The 2011 LiDAR was also much smoother than the 2004 LiDAR. These differences have been observed in other LiDAR comparisons, and are a result of improved LiDAR capture and processing between the two LiDAR capture projects. Statistics extracted from survey points taken at each transect are shown below in

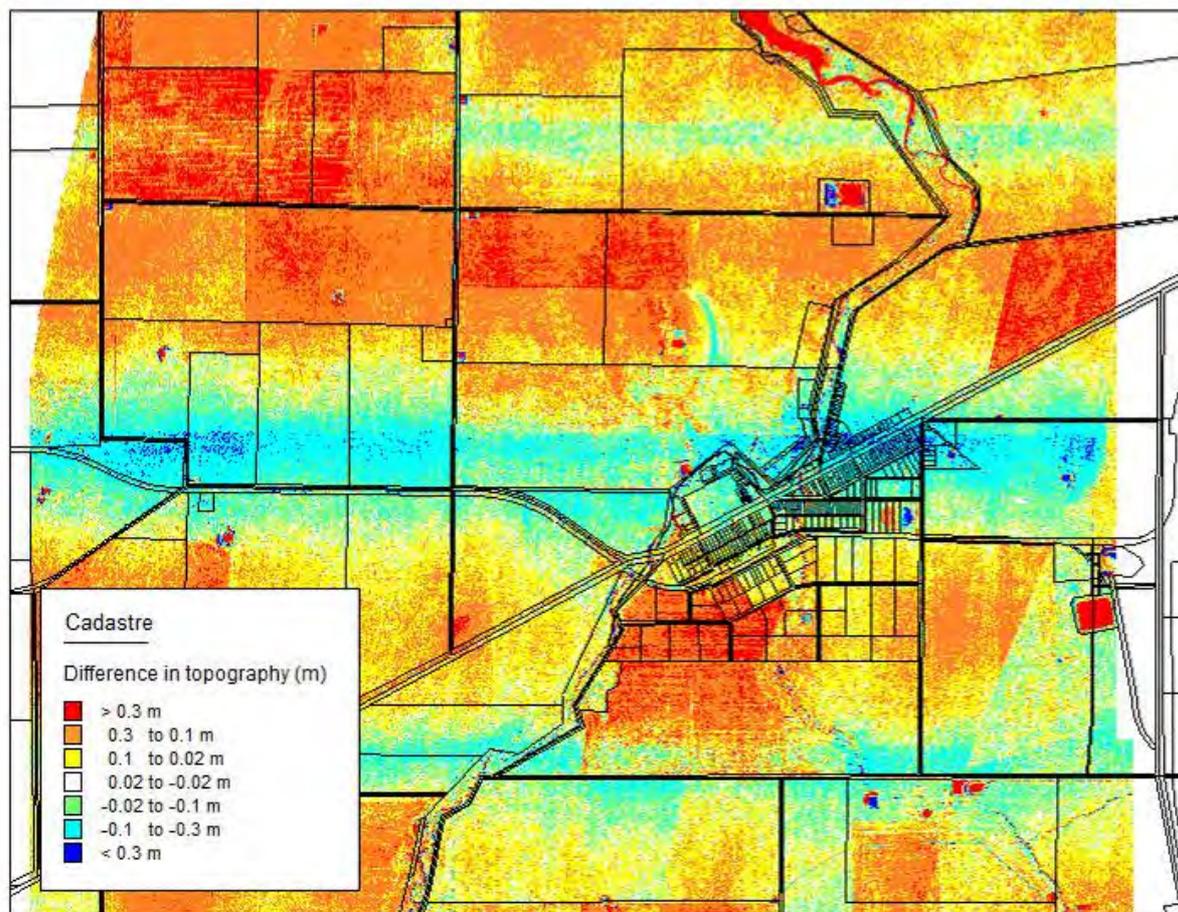
**Figure 2-12** Difference plot of 2011 LiDAR minus 2004 LiDAR

Another obvious non-environmental difference in the two LiDAR datasets is clearly shown in Figure 2-12 with the presence of banding. This banding is a known issue in earlier LiDAR products and has been observed by the authors across numerous other LiDAR datasets. The banding occurs during the processing of the various flight swaths. The new LiDAR does not appear to have the same banding issue.

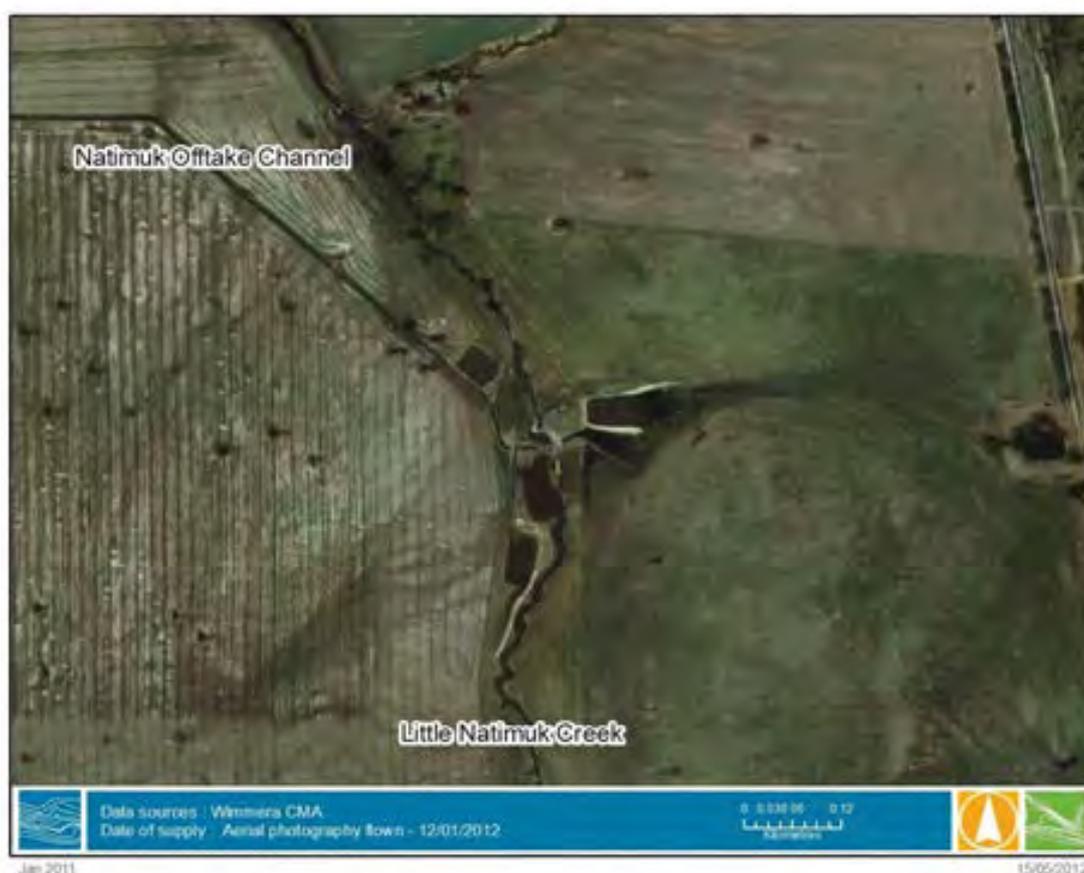
**Figure 2-13 The Little Natimuk Creek and Natimuk Offtake Channel intersection**

The intersection between Little Natimuk Creek and Natimuk Offtake Channel was modelled in 2D to determine its influence on Little Natimuk Creek flows. Using the preliminary estimates of the January 2011 event the model showed that the channel may convey approximately  $0.1 \text{ m}^3/\text{s}$  of an estimated peak flow of  $36.8 \text{ m}^3/\text{s}$  in Little Natimuk Creek. The Natimuk Offtake Channel was considered insignificant in terms of impact on flood flows.

The Natimuk Offtake Channel transfers water across from the Little Natimuk Creek catchment to the Natimuk Creek catchment; it also intersects with Little Natimuk Creek, as shown in Figure 2-13.

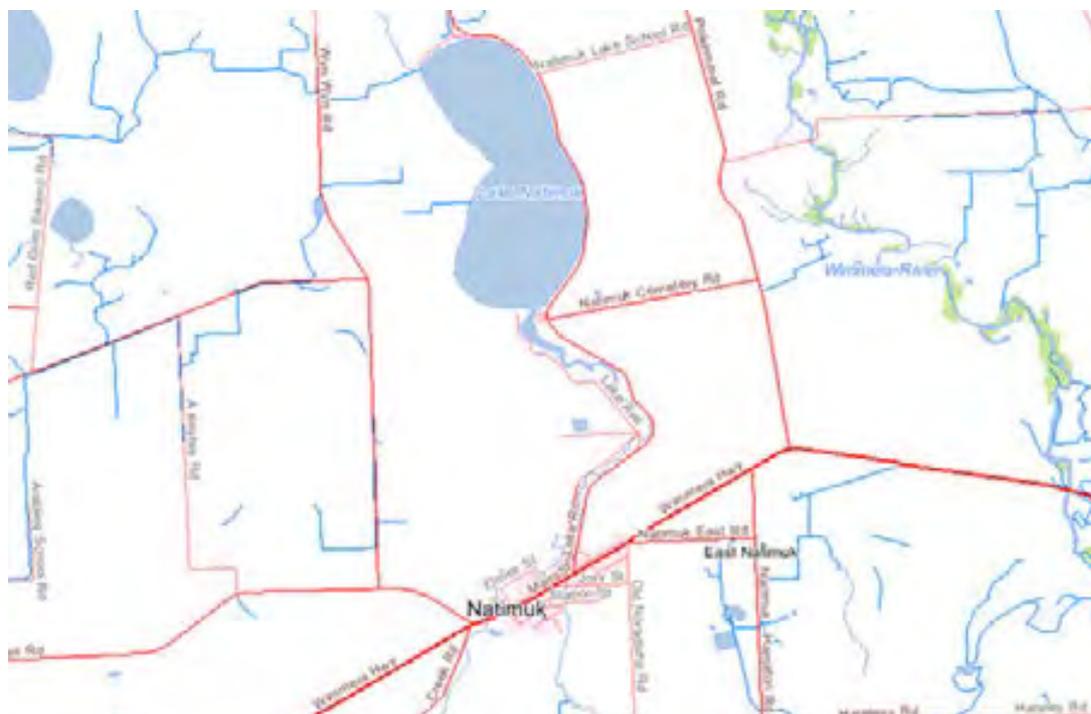
**Figure 2-14** Location of Natimuk Lake downstream of Natimuk (DSE, 2012)

Natimuk Lake is the only recognised water body located in the Natimuk Creek Catchment as shown in Figure 2-14. Natimuk Lake is currently managed by Parks Victoria but was previously managed by the Shire of Arapiles and the Horsham Rural City Council. The lake is also managed by the Natimuk Lake Foreshore Committee. Management of the Natimuk Lake weir is the responsibility of Parks Victoria. Currently this occurs informally and at a local level with staff at the Natimuk Parks Victoria office removing weir boards when it is deemed appropriate. This study has shown there is no necessity for board removal for protection of the Natimuk township.

Natimuk Lake is located approximately 3.5 km downstream of the township and therefore is unlikely to have any impact on flooding within the town. This was tested using the hydraulic model and is discussed later in the report.

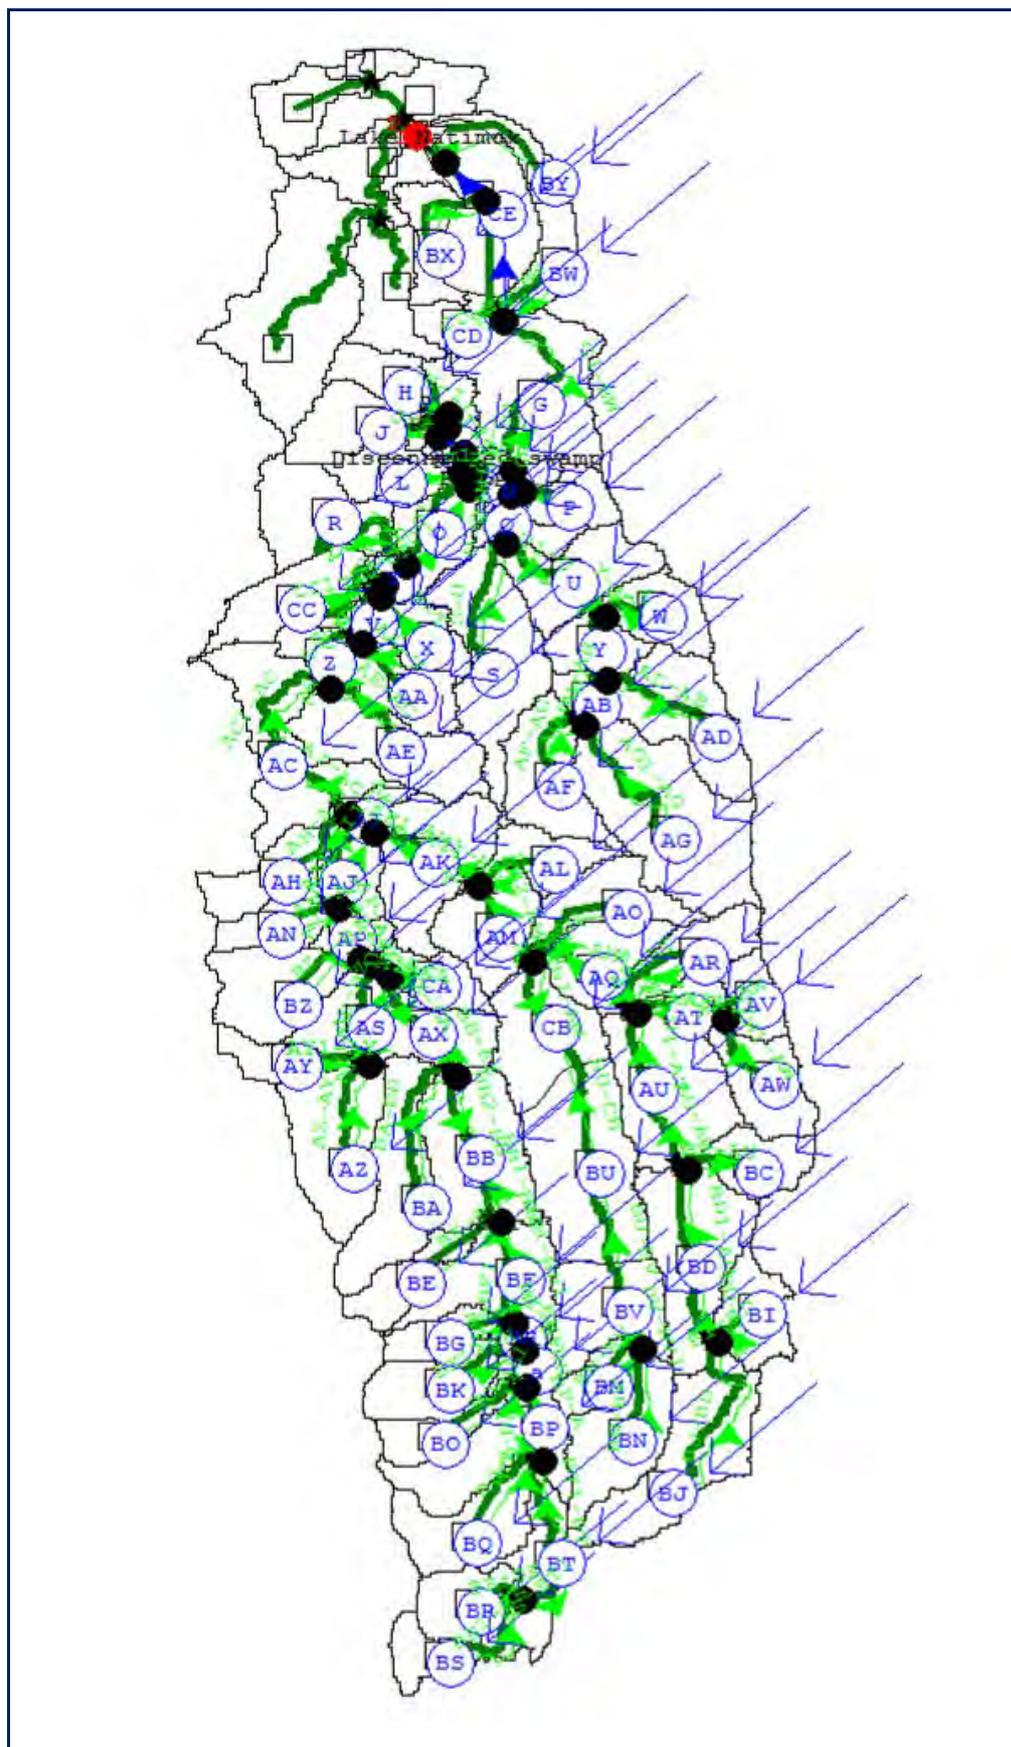
Figure 4-3 Graphical Representation of the RORB Model (MiRORB)

Figure 4-3 shows a graphical representation of the RORB model in RORB GUI highlighting the location of sub-area nodes and reaches.

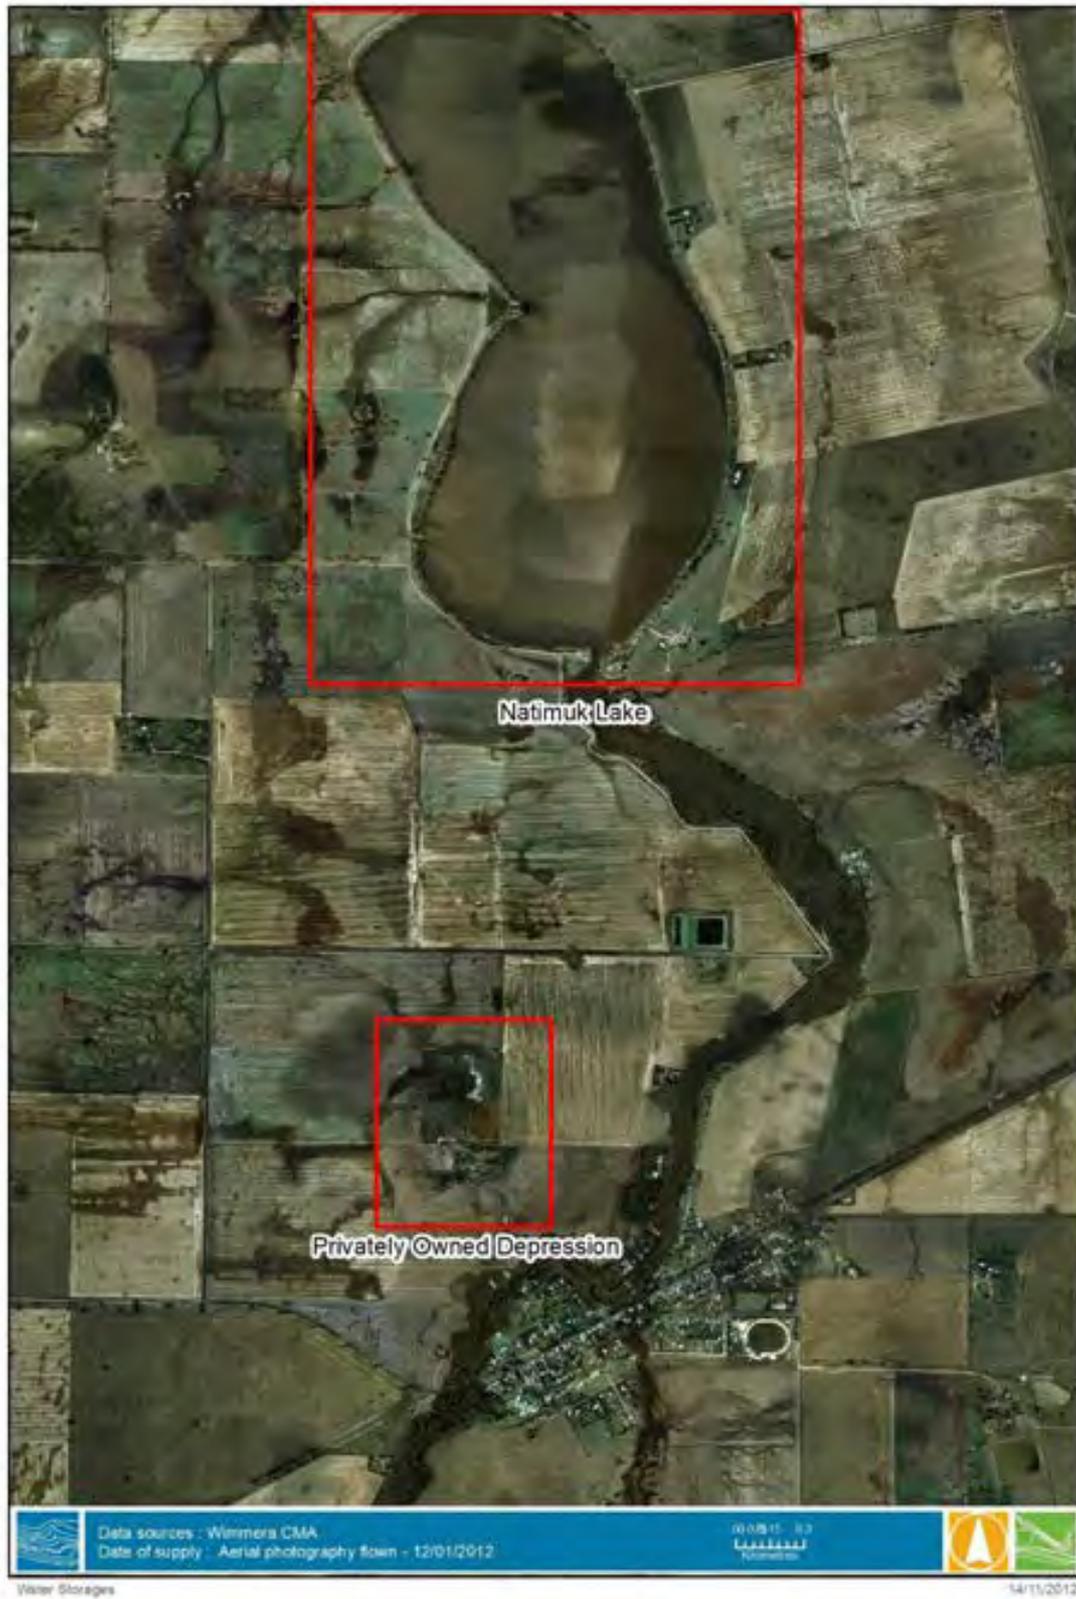
Figure 4-6 Natimuk Lake and the privately owned depression

The storages were not modelled accurately in RORB as hydrographs were extracted upstream of the storages and they were included in the hydraulic model. The privately owned swamp was included in the 2D model domain while Natimuk Lake was included as a 1D extension, downstream of the 2D domain. Their inclusion into the hydraulic model provided an understanding of the potential attenuation they may cause, as well as the impact their initial storage levels may have on flows and flood levels at Natimuk. This allowed a range of Natimuk Lake water levels in to be modelled and assisted with the assessment of mitigation options.

Figure 4-6 below shows Natimuk Lake and the privately owned depression.
