# Natimuk Flood Investigation Study Report

Project Name	Natimuk Flood Investigation
Client	Wimmera CMA
Client Project Manager	Paul Fennell
Water Technology Project Manager	Ben Hughes
Report Authors	Ben Hughes
Job Number	2120-01
Report Number	R06v02
Document Name	2120-01R06v03.doc

Following the December 2010 and January 2011 flood events, Water Technology was commissioned by the Wimmera CMA to undertake the Natimuk Flood Investigation. This included detailed hydrological and hydraulic modelling of Natimuk Creek and Little Natimuk Creek, flood mapping of the Natimuk township area, flood mapping of the entire upstream catchment, and also provided recommendations for flood mitigation works.

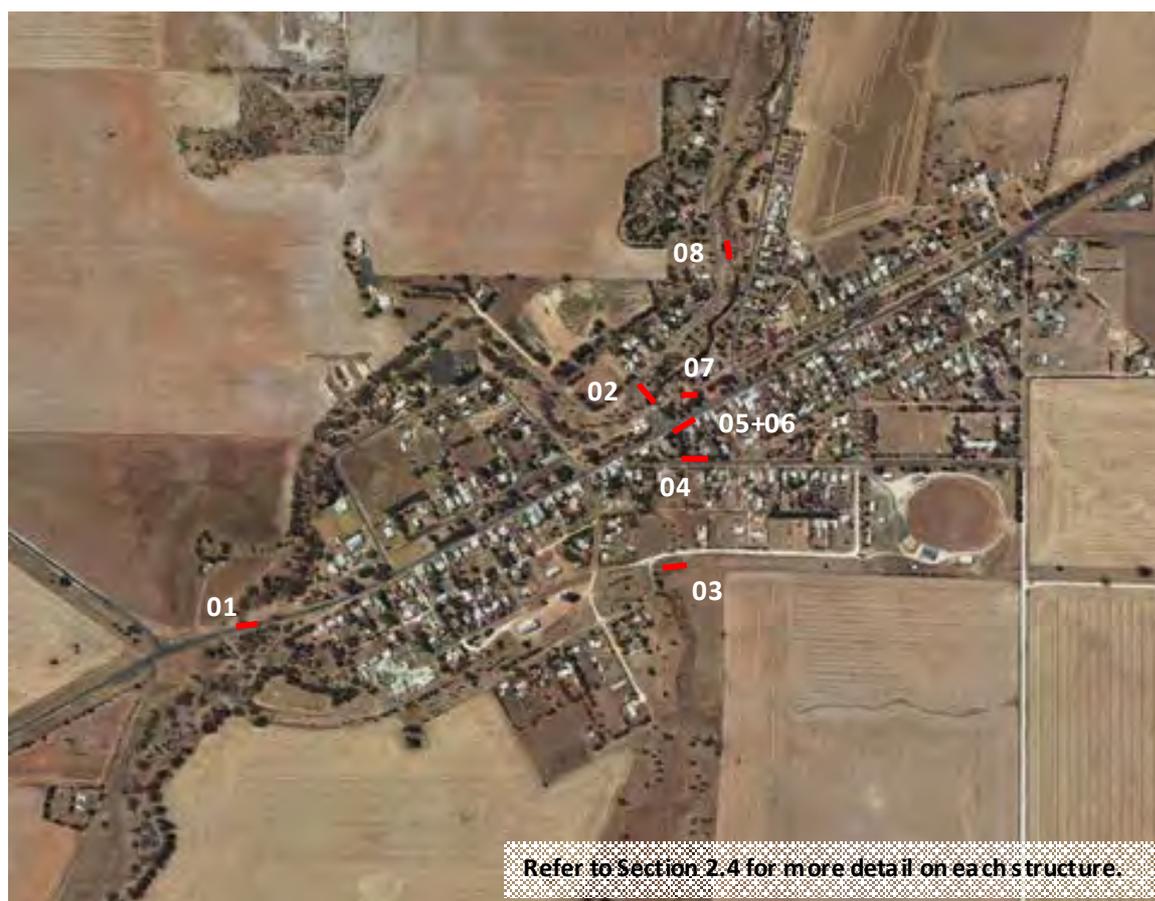
**Figure 4-8 Key hydraulic structures through Natimuk**

and were surveyed by Ferguson and Perry Surveying. Figure 4-8 shows the location of key waterway structures within Natimuk, with discussion on each structure shown in Section 2.4.1.

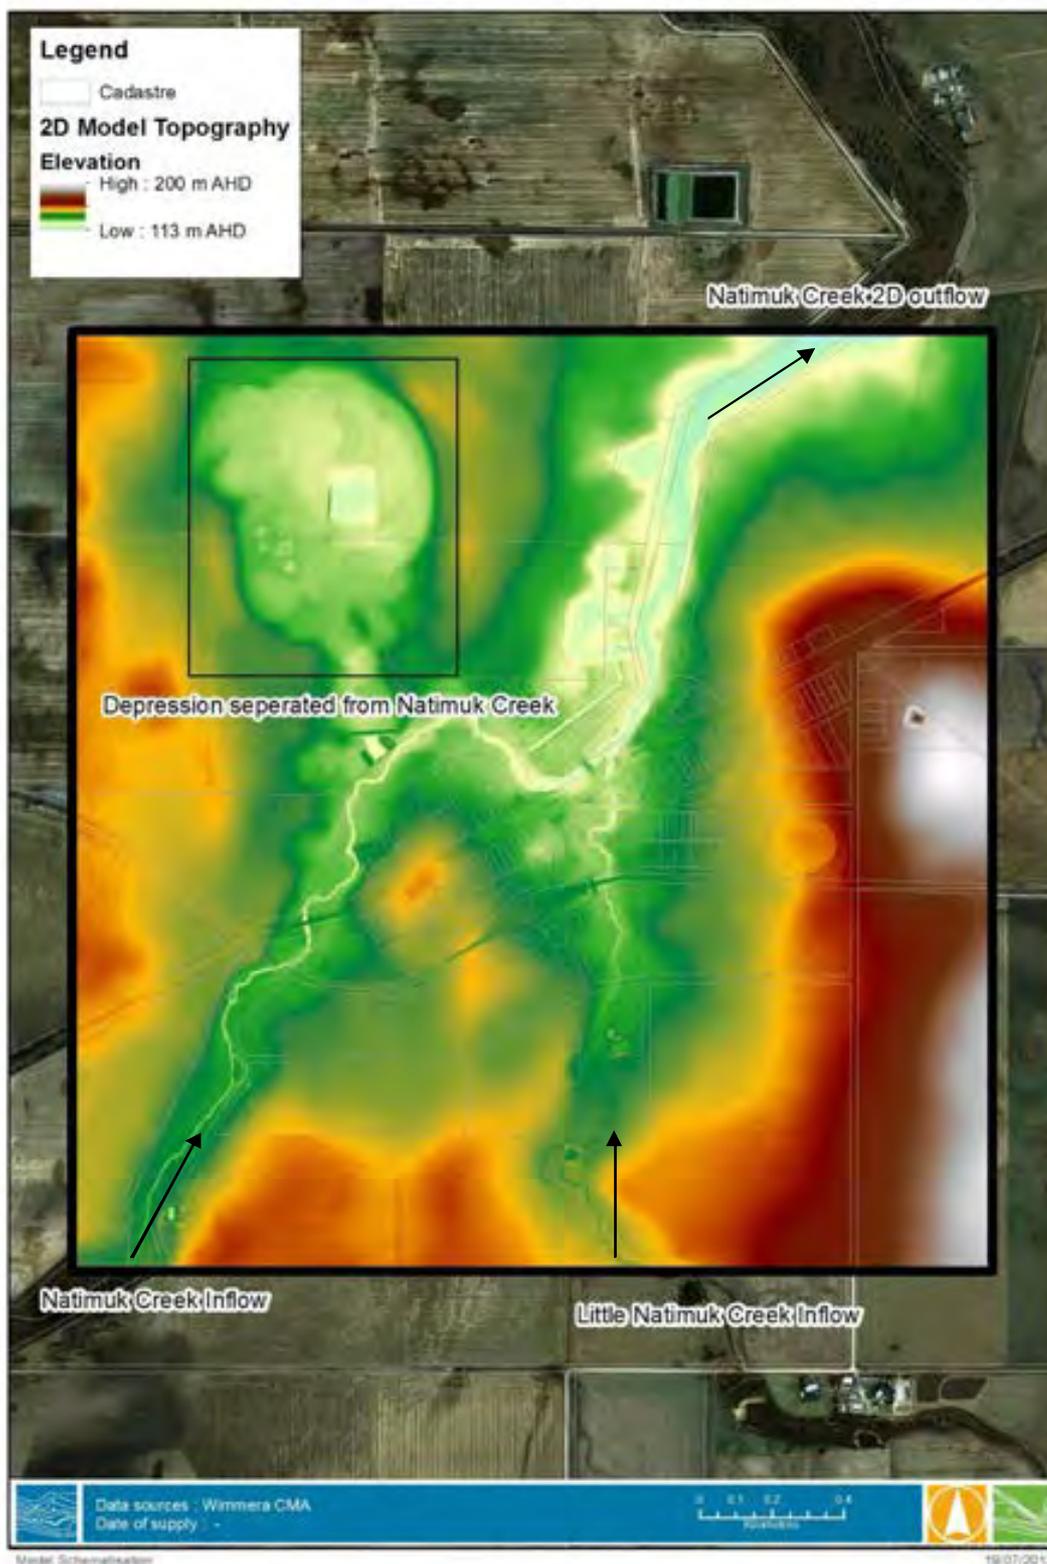
Figure 4-9 Hydraulic model topography grid

The 3 m grid size yielded a model with 852 x 879 grid cells. The model topography is shown below in Figure 4-9.

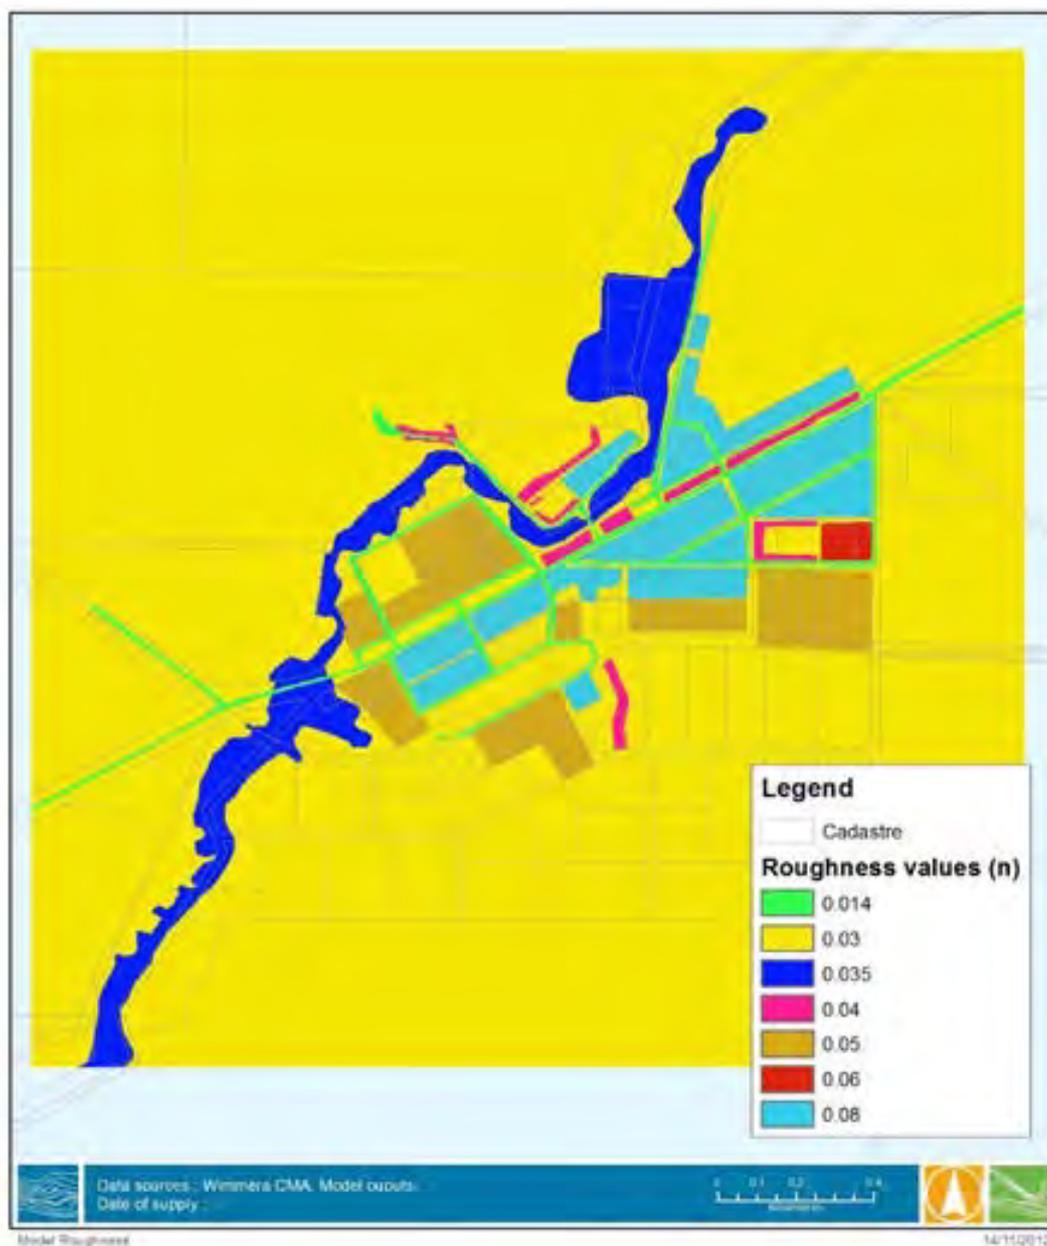
**Figure 4-10** Hydraulic model roughness values

Variations in hydraulic roughness across the floodplain were represented spatially as a 2D map, Figure 4-10. The hydraulic roughness (Manning's 'n') values for the floodplain were based primarily on aerial photography of Natimuk and observations from the site inspection undertaken. Roughness categories are shown below in Table 4-2. These values are consistent with values recommended in Chow (1959)<sup>9</sup>.

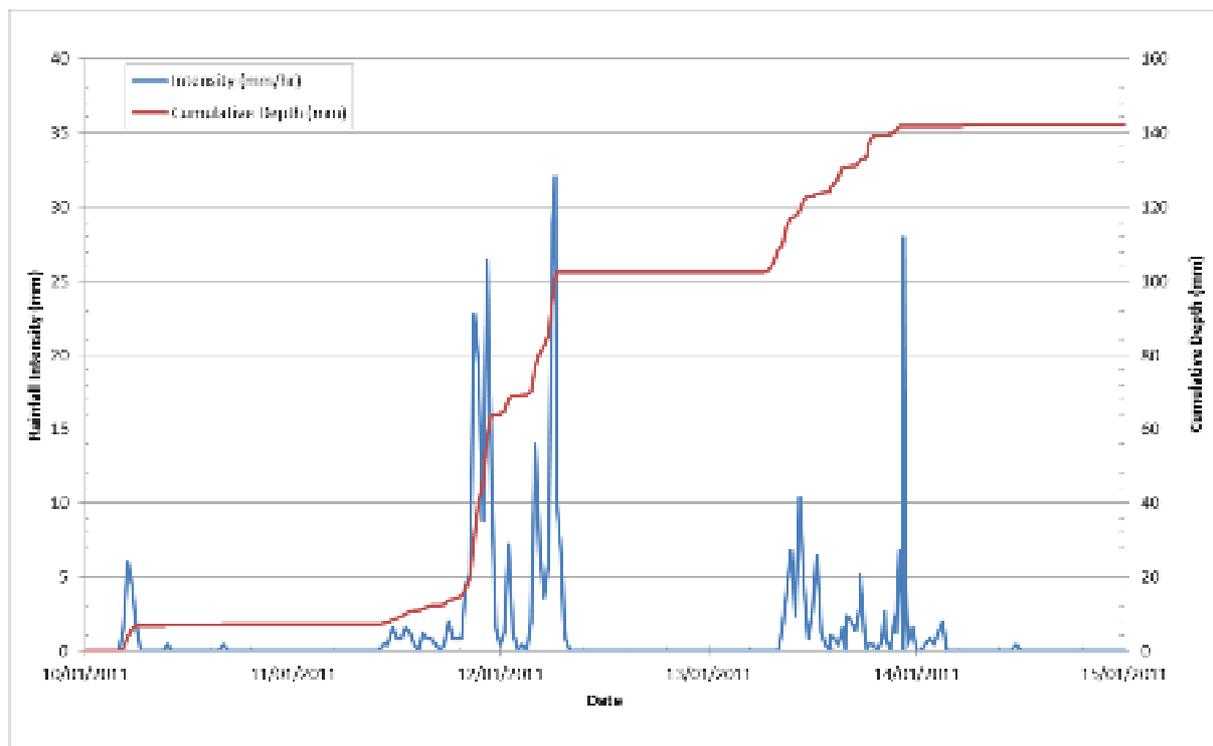
**Figure 5-7 Horsham Automatic Weather Station (AWS) Pluviograph records – January 2011 Event**

The two pluviograph stations are located a short distance apart (Approx. 12 km) on the same side of the catchment. The temporal distribution of rainfall was tested using both gauging stations within RORB as there was significant variance between the two patterns.

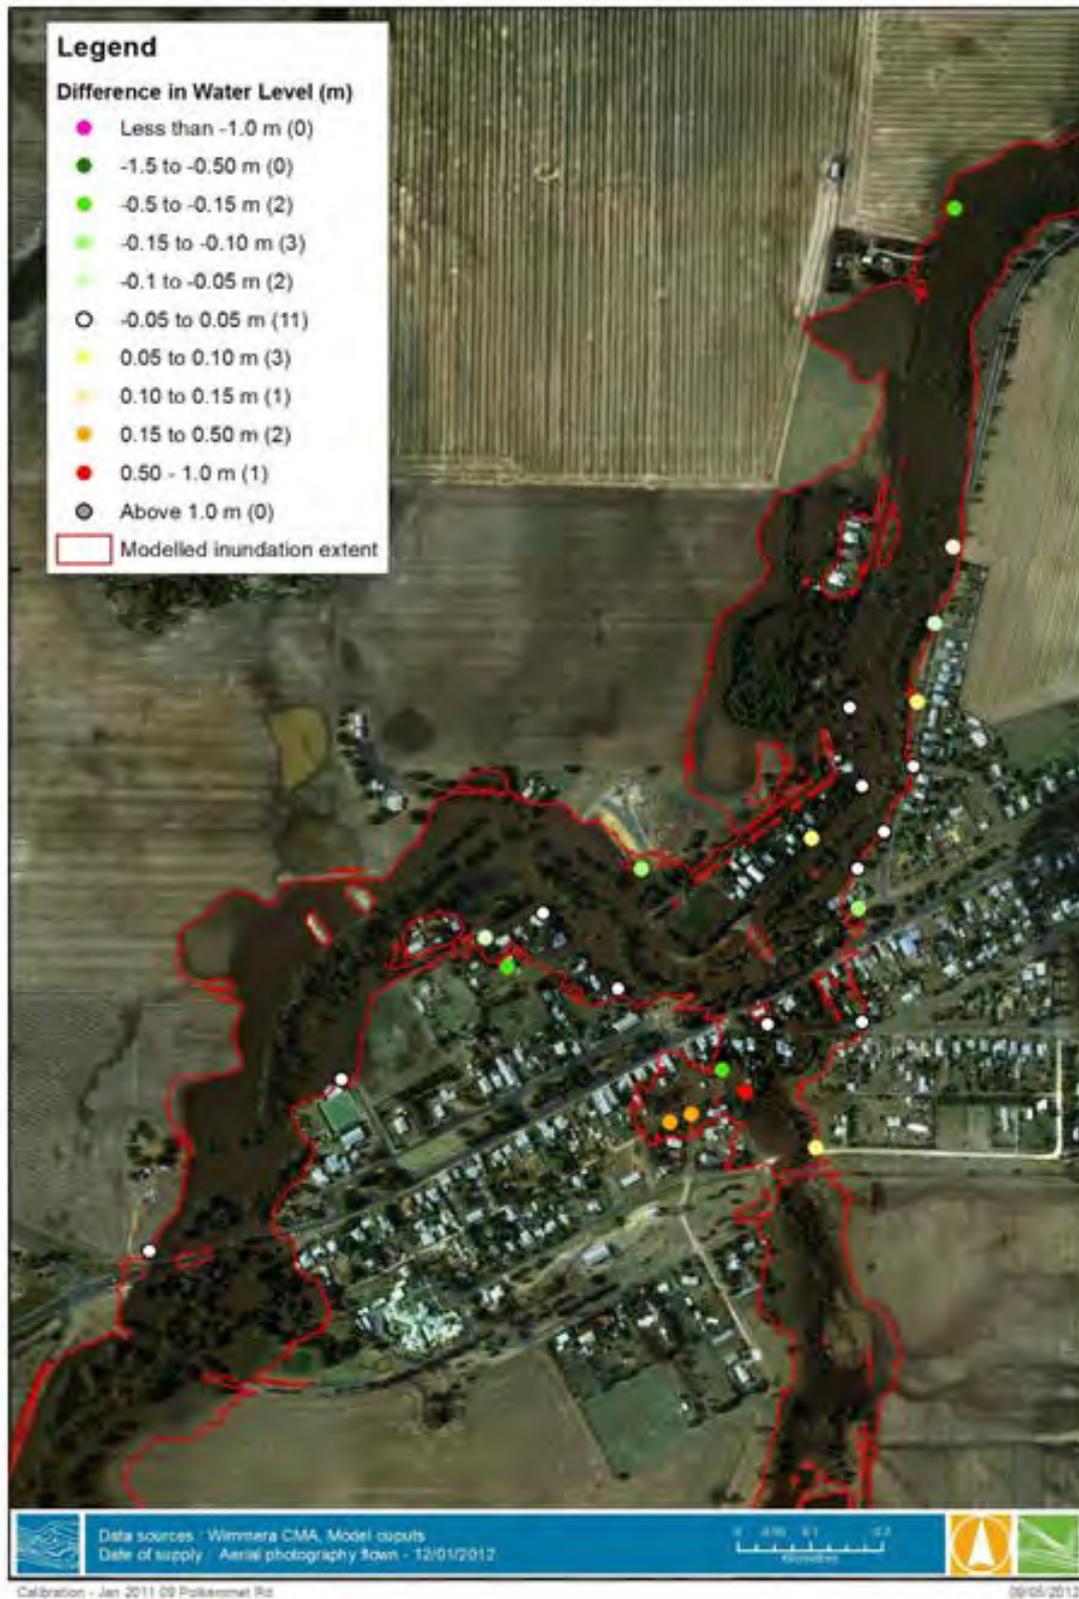
Figure 5-13 January 2011 hydraulic model results using the Polkemmet Road temporal pattern

The aerial flood photograph shown in the below figures was taken during the flood event on the 12<sup>th</sup> January 2011 between 5:28 and 6:35 pm (3.5-4.5 hrs after the peak water level had passed on Natimuk Creek). Anecdotal evidence and RORB modelling suggests Little Natimuk Creek peaked before Natimuk Creek, supported by the drained areas shown in the aerial flood photograph.

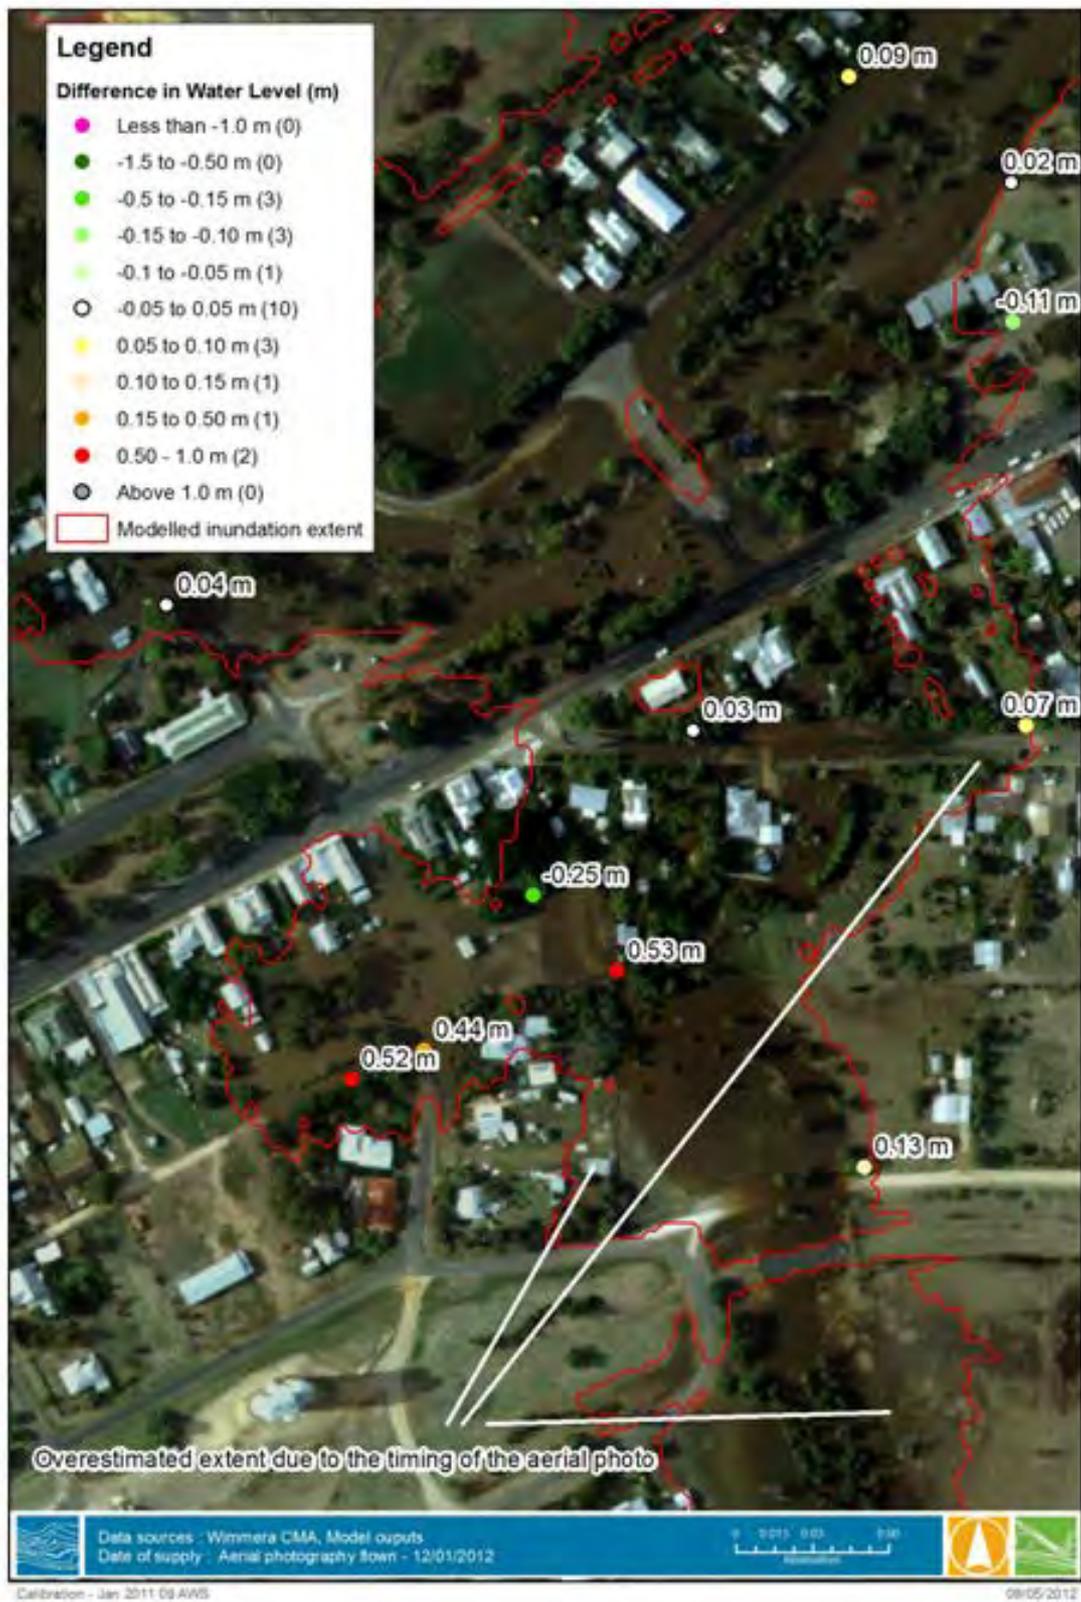
Figure 5-15 January 2011 hydraulic model results on Little Natimuk Creek using the Horsham AWS temporal pattern

Four points outside the  $\pm 0.15$  m range were clustered on Little Natimuk Creek around Schmidt Street. These points are shown below in Figure 5-15. Points upstream of this area matched within  $\pm 0.15$  m and downstream points matched within 0.05 m. Of the four points, three show model results to be higher and one lower. The two points on Schmidt Street and Depot Lane are both described in the survey as ‘ground level’, meaning they were pegged at the extent of inundation. However, the aerial photography of the event contradicts this information suggesting the flood extent was greater than the pegged location, suggesting these survey points may be in error.

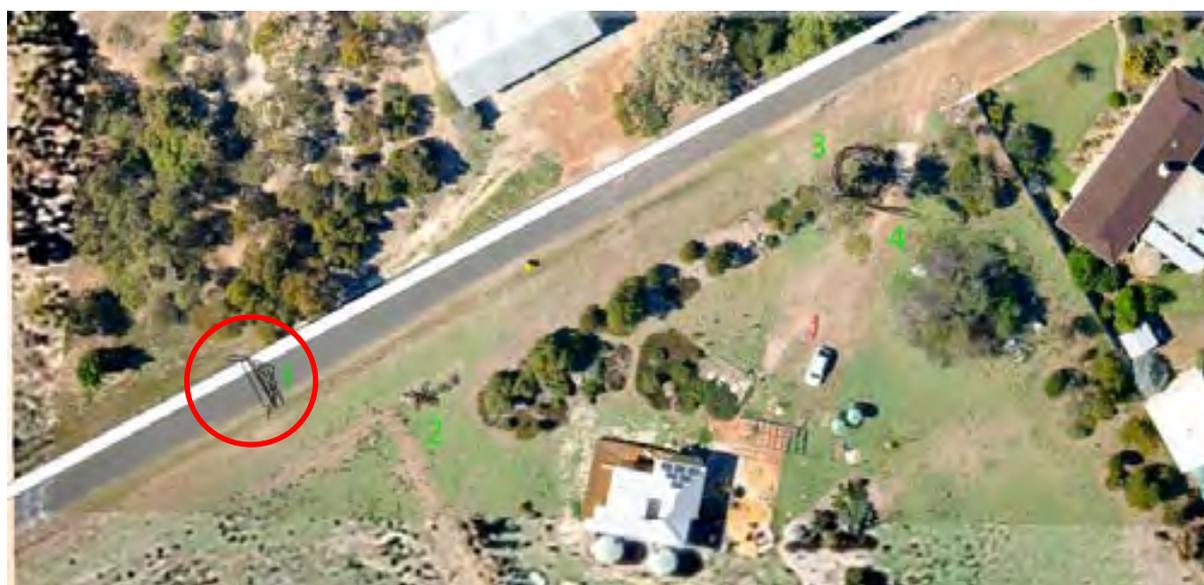
**Figure 5-18** December 2010 anecdotal flood extent on Elmes Street

A member of the Natimuk Flood Investigation Steering Committee submitted a marked aerial photograph demonstrating where he believed the December 2010 flood waters reached on Elmes Street. This matched closely to the modelled flood extent as shown in Figure 5-18.

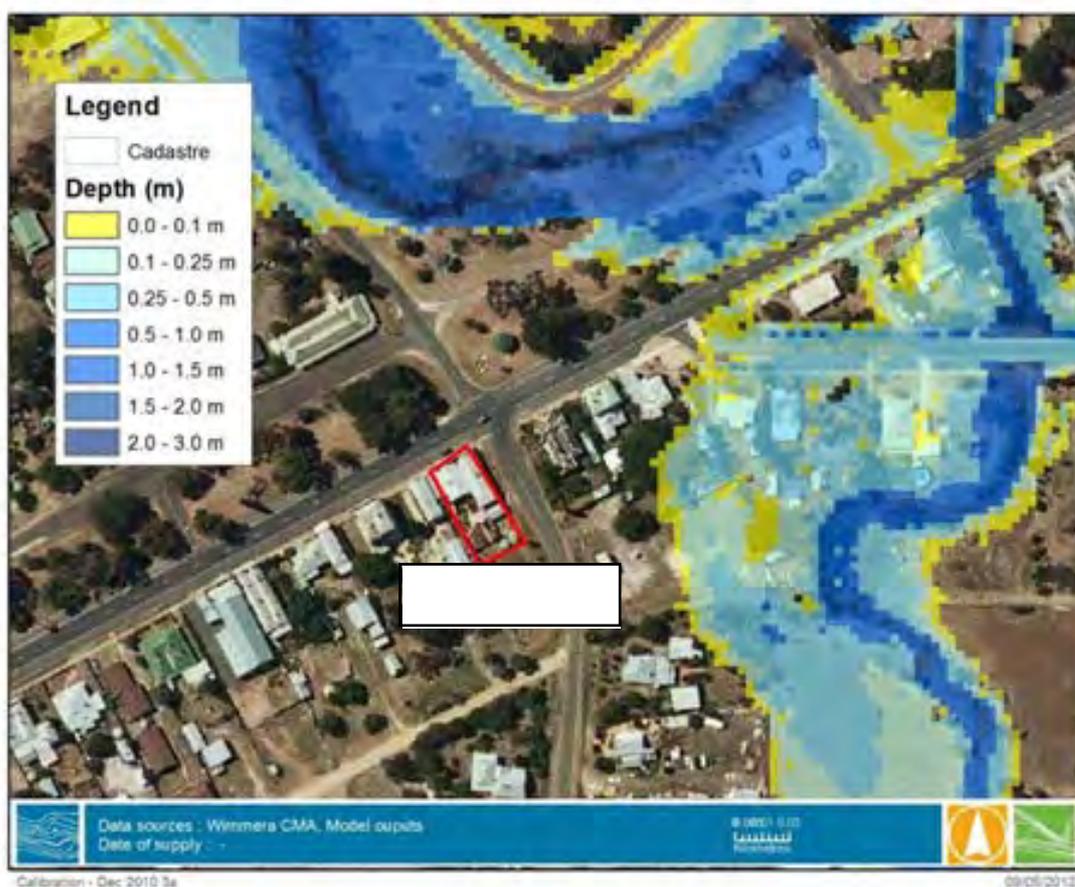
**Figure 5-20 December 2010 modelled flood extent at 87 Main Street**

Comment	Model representation
'January was worse'	Model predictions have shown the January event to be have higher inundation than December
'Water did not overtop the Main Street in Natimuk'	Modelled water levels are not overtopping the Main Street
'January was 40 cm higher' – comment was made in reference to 19 Elmes Street	Difference in the two modelled events is 0.27 m
January was 20 cm higher' – comment was made in reference to 59 Lake Avenue	Difference in the two modelled events is 0.32 m
January was 61 cm higher' – comment was made in reference to Natimuk Main Street	Difference in the two modelled events ranges between 0.4-0.5 cm
Water covered the back of the property and entered the shed – comment was made in reference to 87 Main Street	Water from Little Natimuk Creek does not quite reach the property but owners have stated they were affected by overland flow from the west. See Figure 5-19.

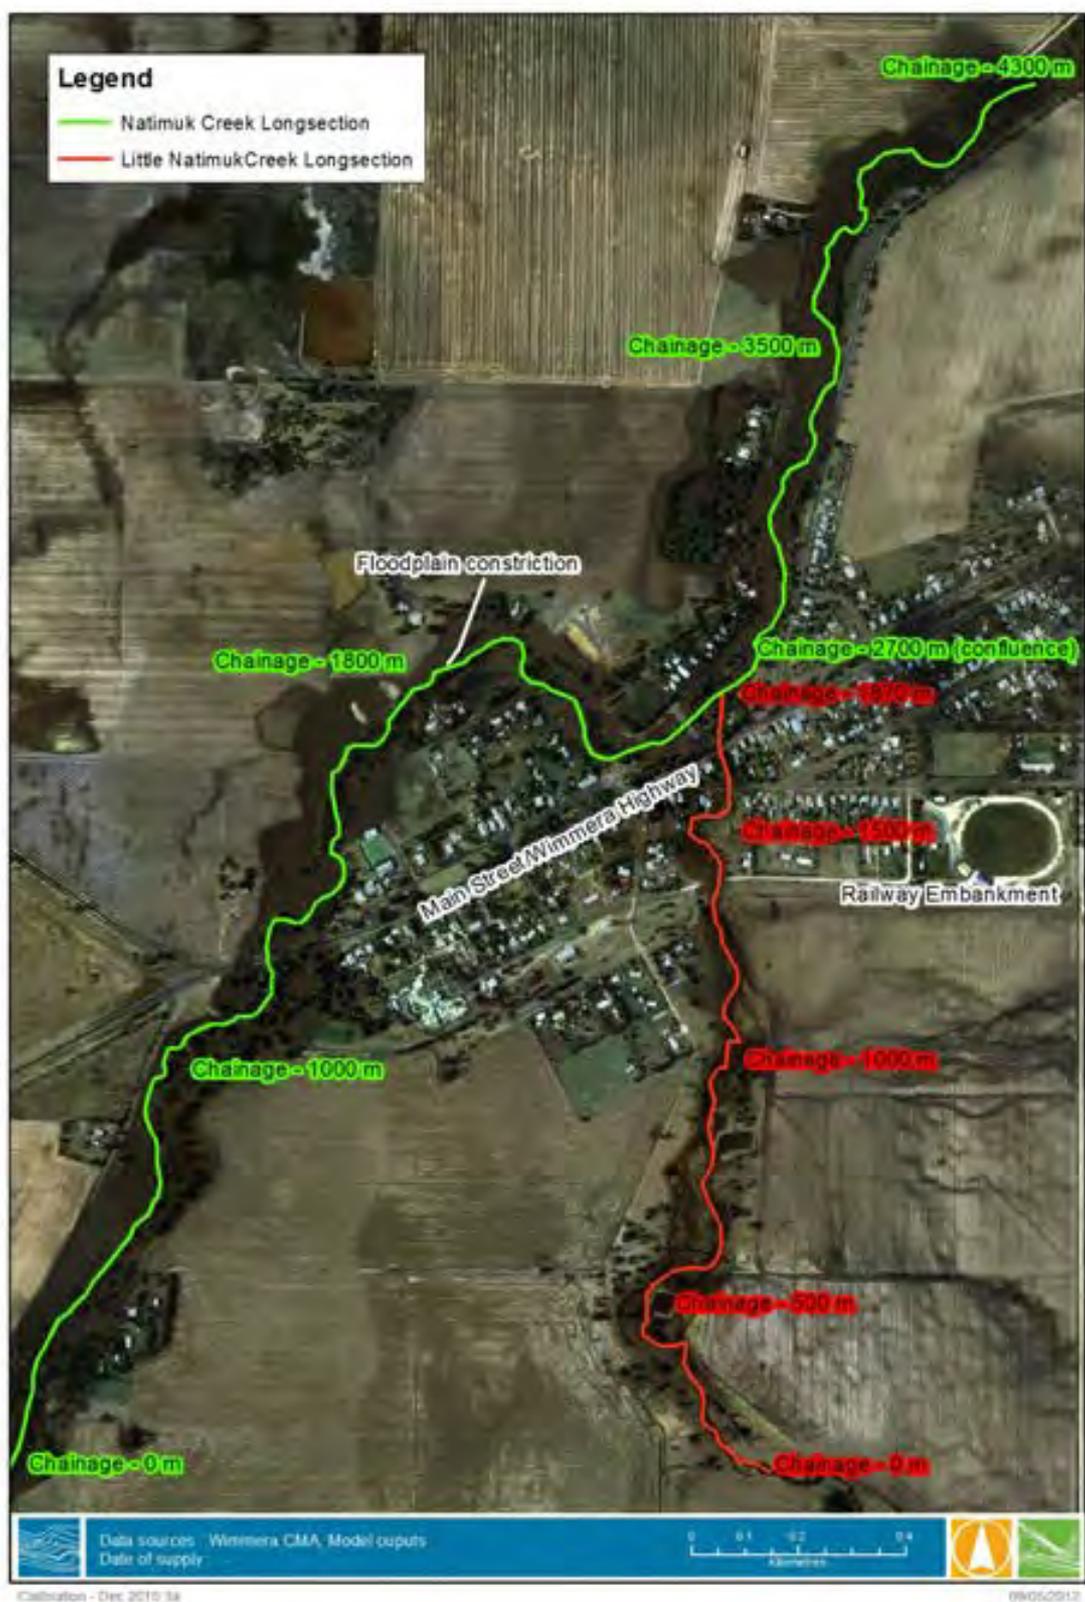
Figure 6-8 Long-section locations along Natimuk Creek and Little Natimuk Creek

Long-sections of both Natimuk and Little Natimuk Creek were developed to show the impact of structures on the range of ARI events. These are shown below in Figure 6-9 and Figure 6-10. The long sections were extracted along the centreline of each waterway as shown below in Figure 6-8.

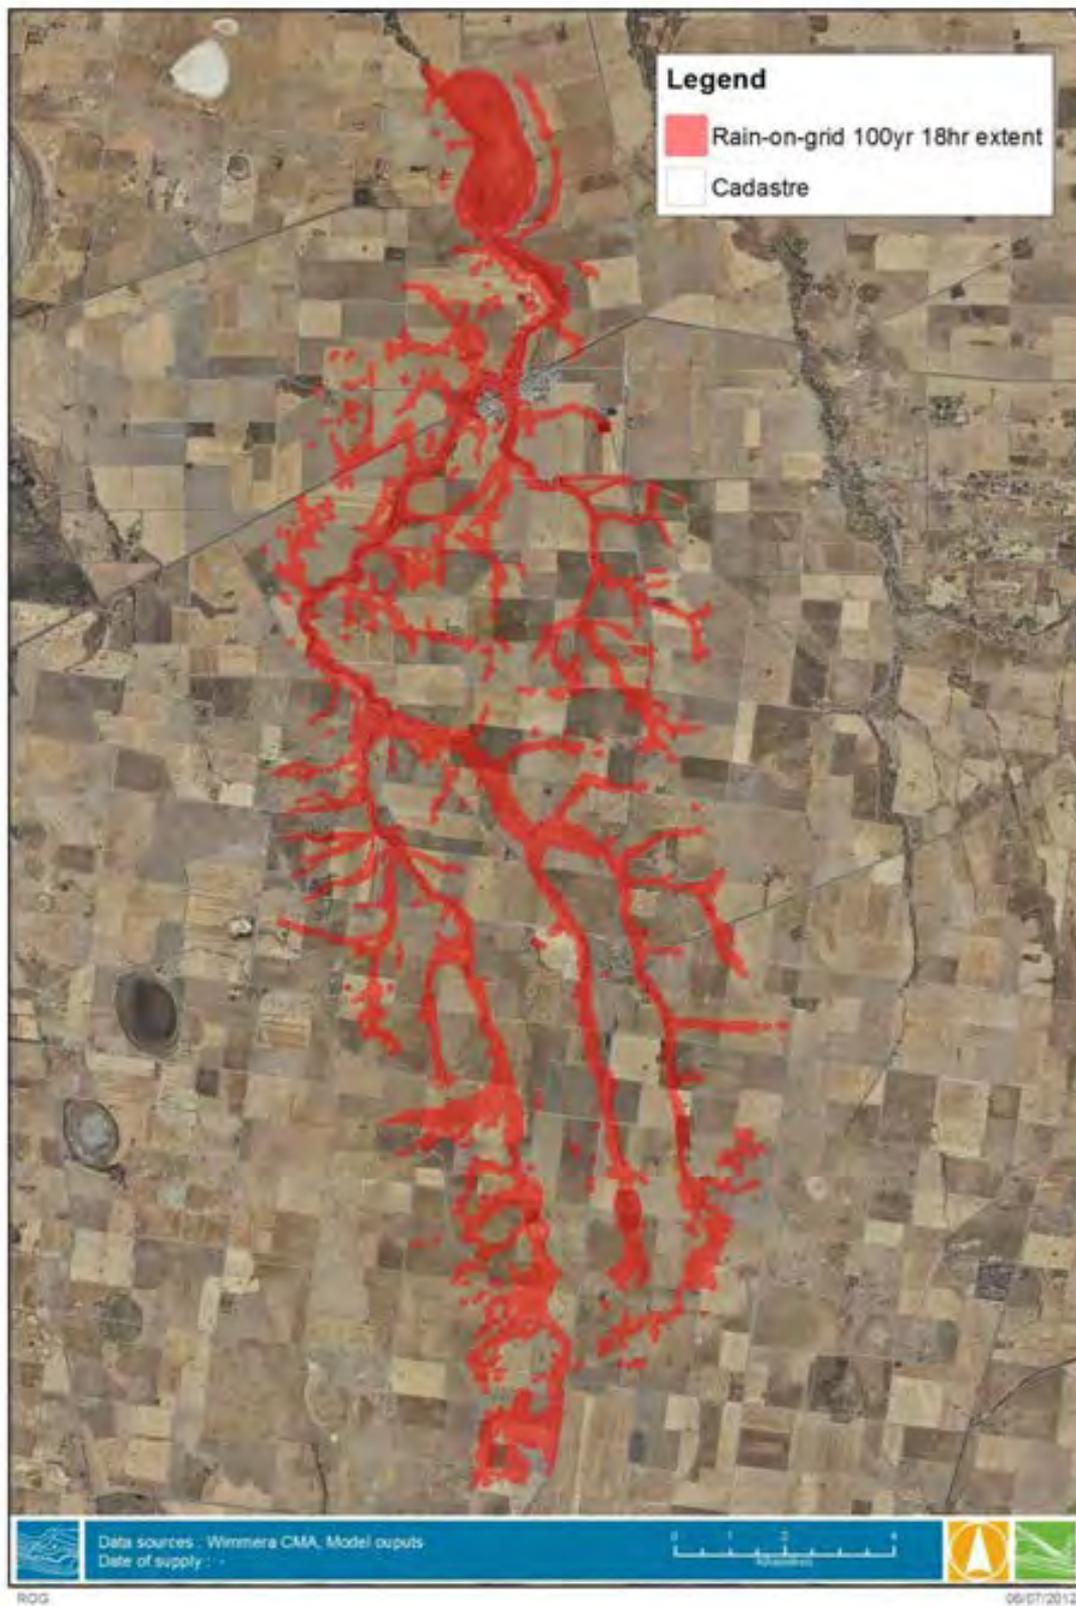
**Figure 7-8** 100 year ARI rainfall-on-grid flood extent using an envelope of the 18 and 2 hour durations

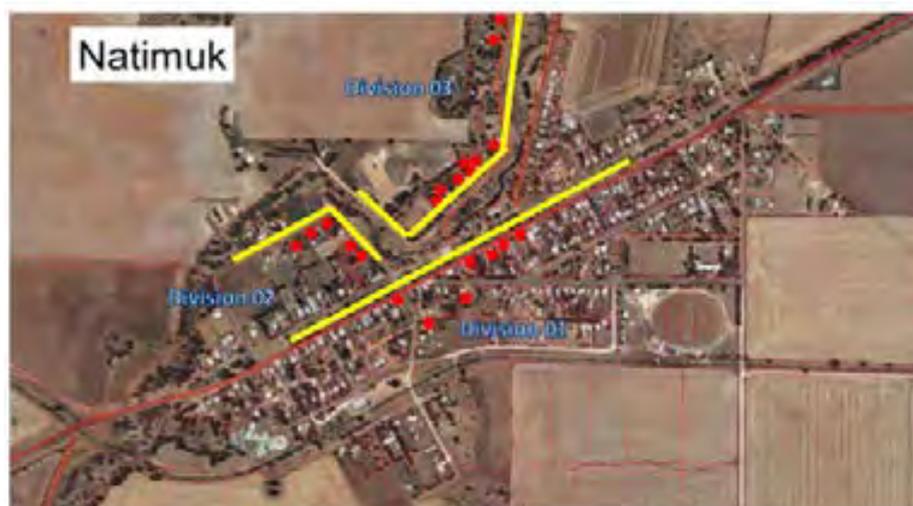
**Figure 8-1 Natimuk hydraulic divisions, showing properties flooded above floor during January 2011 (Wimmera CMA)**

- 01 - Properties south of the Wimmera Highway (largely impacted by Little Natimuk Creek);
- 02 - Properties on Elmes Street; and
- 03 - Properties on Lake Avenue.

These divisions are based on the location of above floor flooded properties and also the different flood mechanisms that cause the flooding at those properties. The three divisions are highlighted in Figure 8-1, showing the dwellings impacted above floor during January 2011.

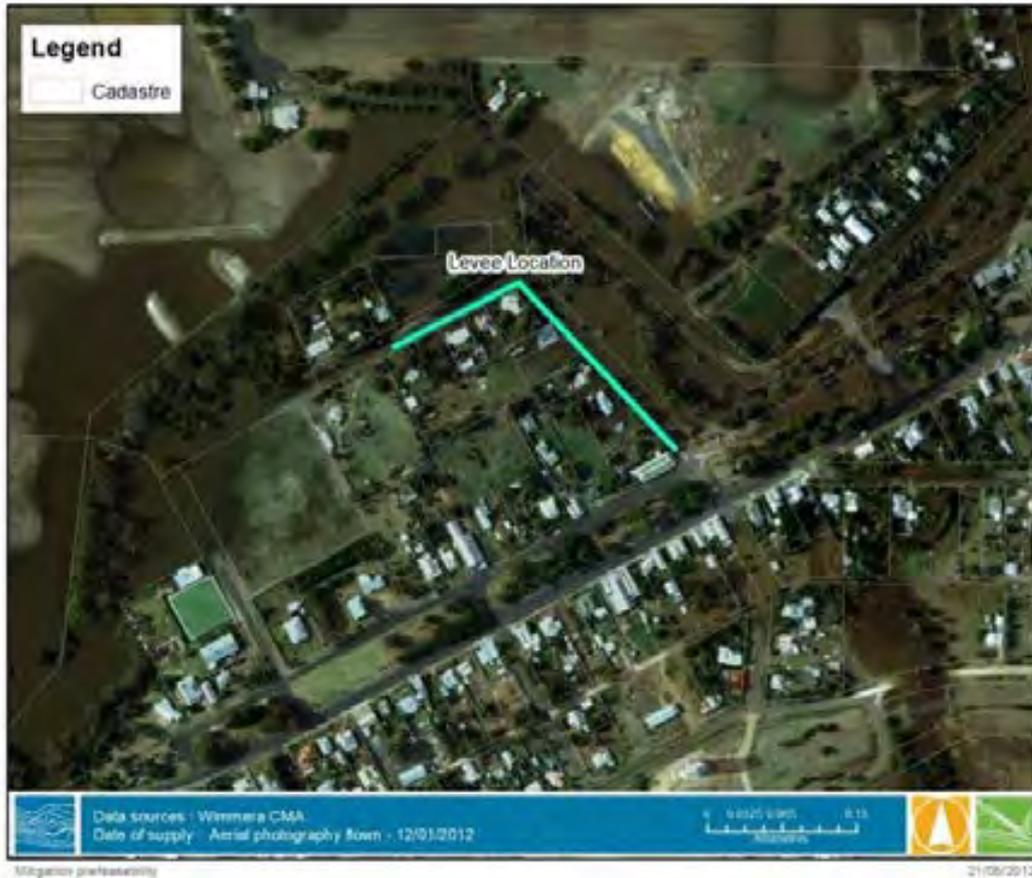
A levee along Elmes Street was assessed to prevent water entering the properties from Natimuk Creek to the north and east. During January 2011 five properties were impacted above floor level along Elmes Street. Figure 8-4 shows the potential location of the Elmes Street levee and the properties which may be directly impacted by its construction.

Figure 8-4 Potential location for Elmes Street Levee

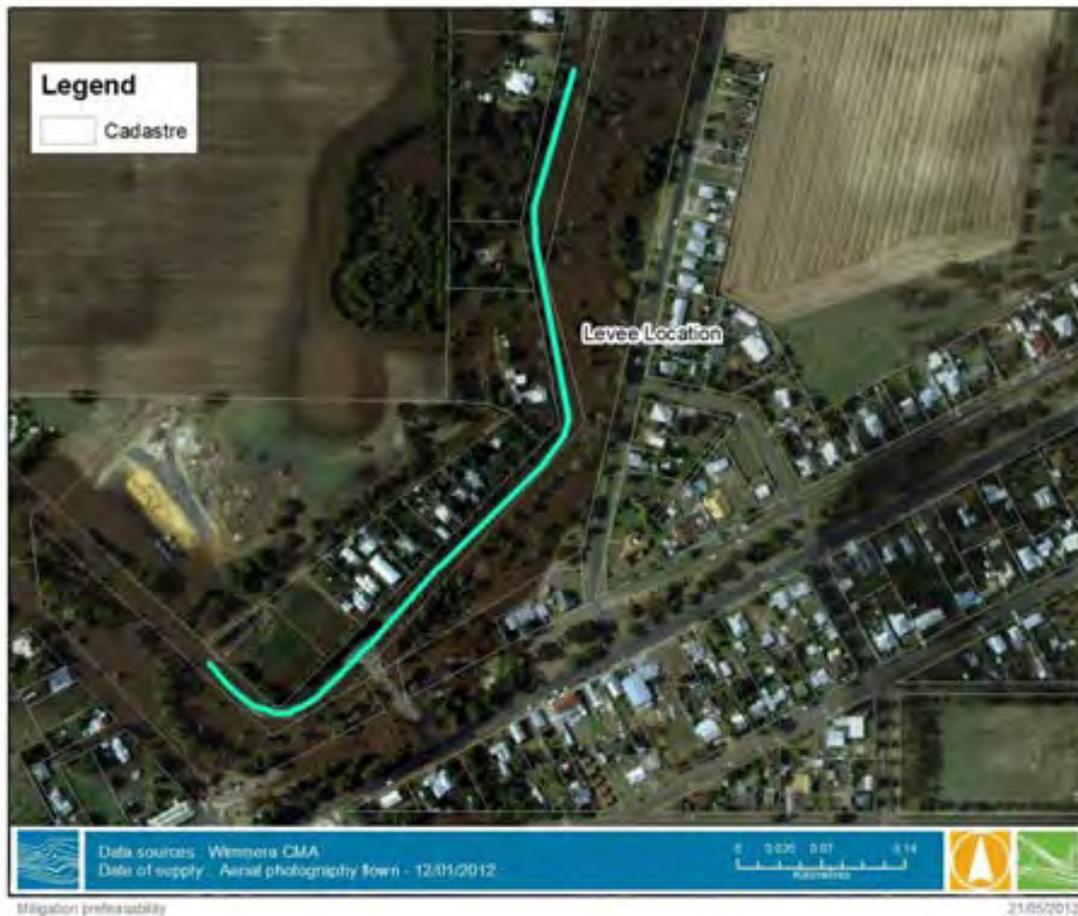
A levee along Lake Avenue was assessed, preventing water entering properties from Natimuk Creek. The levee was assessed on the Natimuk Creek side of Lake Avenue. During January 2011 eleven properties were impacted above floor level along Lake Avenue. Structural arrangements of the bywash channel to the north of Lake Avenue would also need to be investigated during this option. Figure 8-5 shows the potential location of the Lake Avenue levee.

**Figure 8-5 Potential location for Lake Avenue Levee**

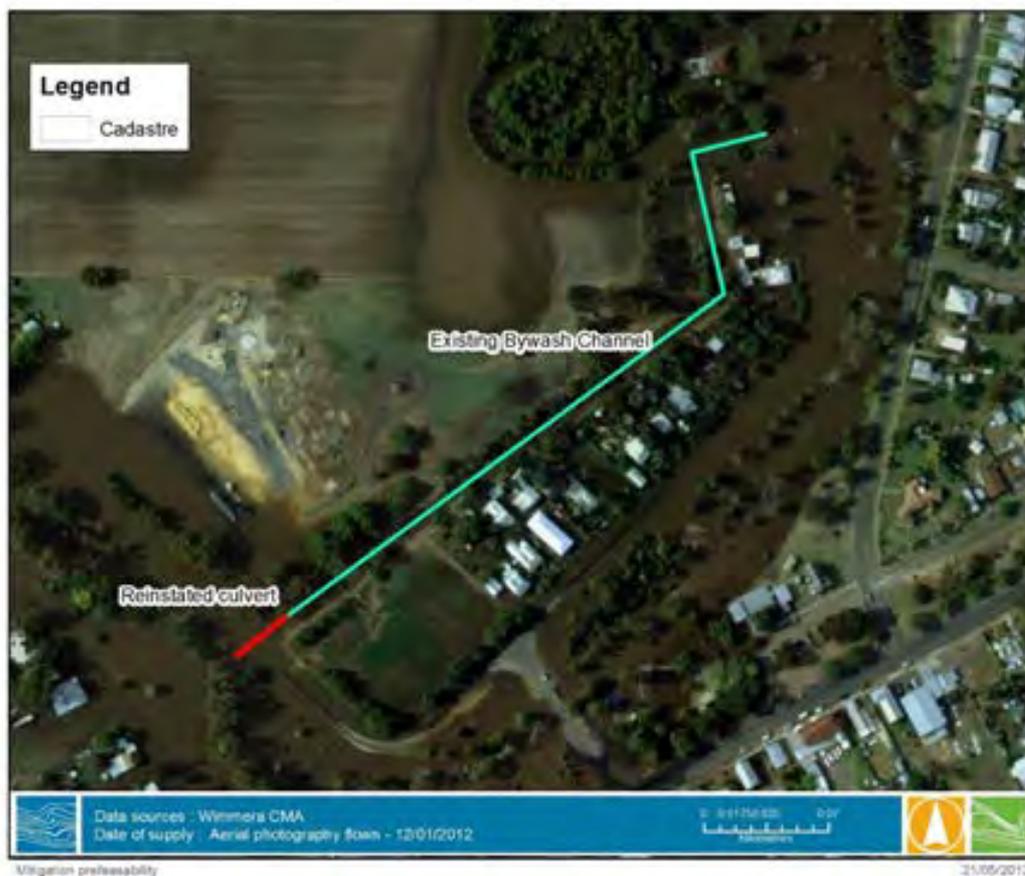
A channel exists to the rear of Lake Avenue. Anecdotally the channels original purpose was to bypass flood water around the Main Street of Natimuk. Since its construction the channel was blocked by Lake Avenue. A culvert previously existed under Lake Avenue but this was not reinstated during road works, this culvert could be reinstated bypassing flow around Natimuk. If the culvert were to be reinstated it is likely the channel would also require some maintenance. Figure 8-6 shows the location of the existing channel, location of the potential culvert.

**Figure 8-6 Lake Avenue bywash**

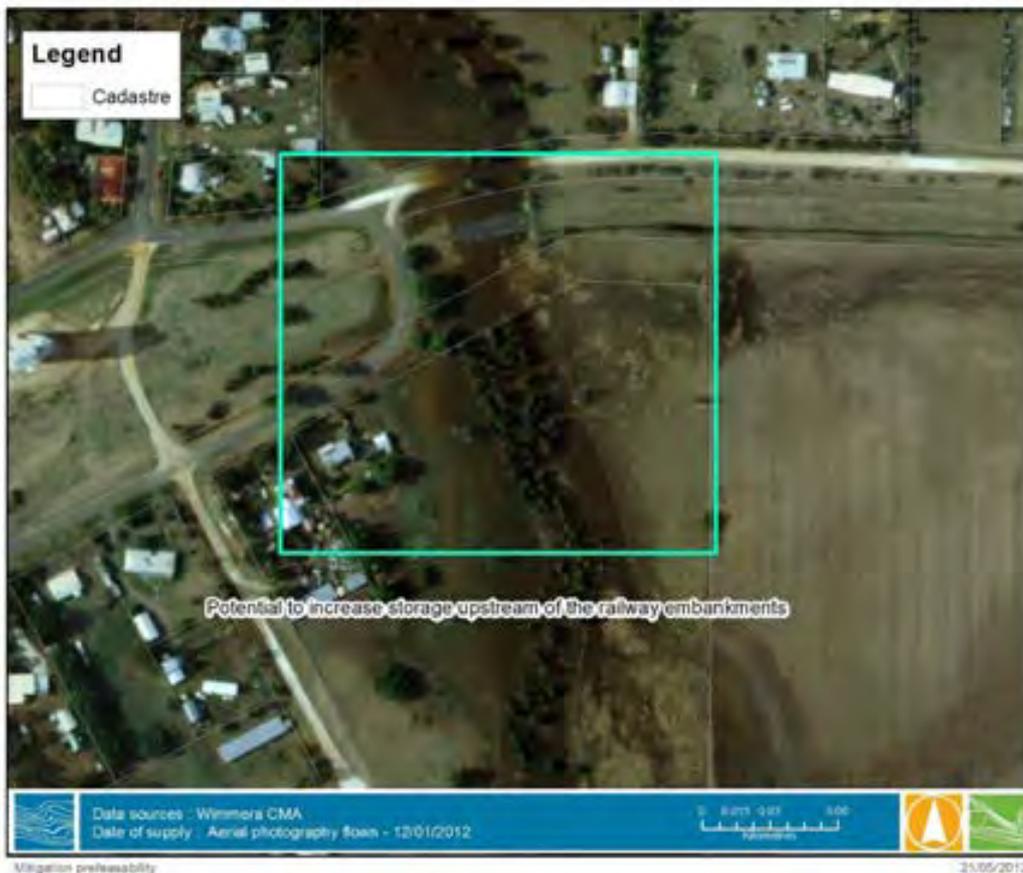
**Figure 8-8 Location of potential retarding basins on Little Natimuk Creek**

Figure 8-8 shows areas which may be suitable for a retarding basin a Little Natimuk Creek

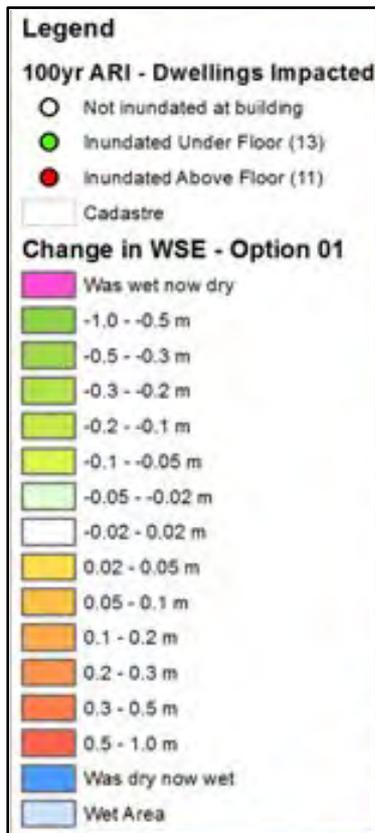
The **Pink** 'Was wet now dry' indicates areas which have become dry in the mitigation scenario, this will be most apparent in areas which are protected by a levee. The negative numbers are all shown in **Green**. These numbers indicate areas which have decreased in depth due to the construction of the mitigation option with the darker shades a greater reduction.

Figure 8-10 Mitigation Option assessment legend

Comparisons are shown throughout this section using the colour scale shown below in

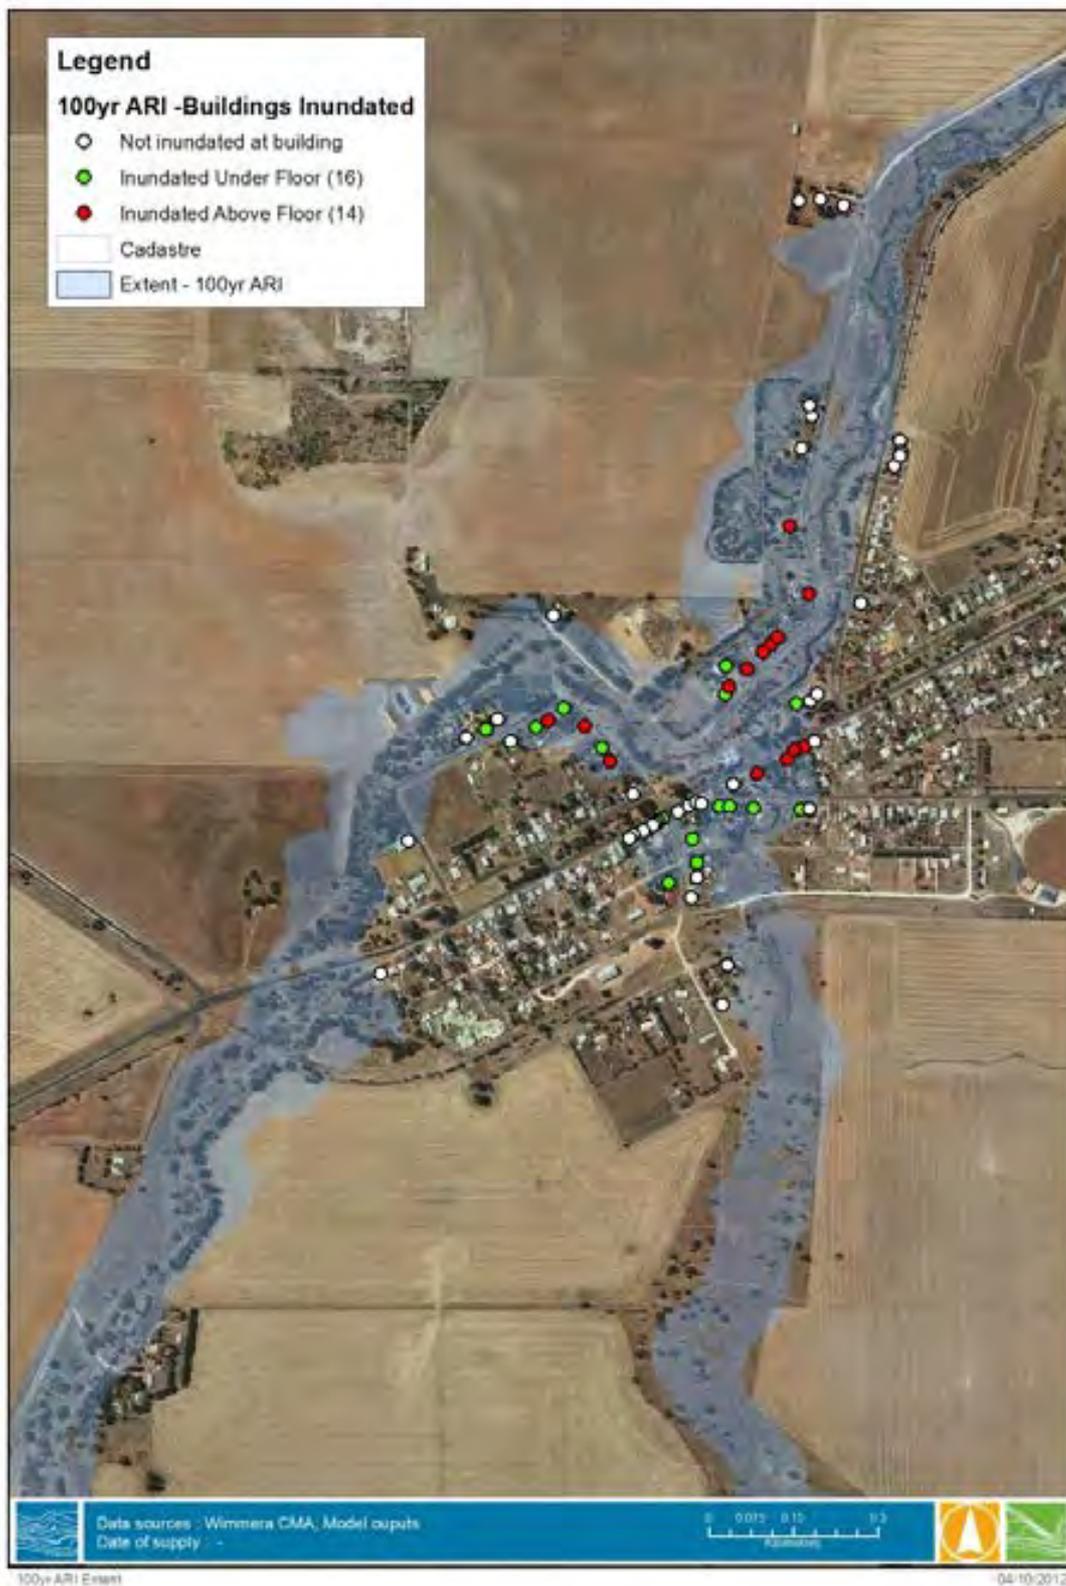
**Figure 8-11 Existing 100 year ARI event model results**

The existing conditions 100 year ARI event model results are shown below in Figure 8-11.
