# Natimuk Flood Investigation Study Report

Project Name	Natimuk Flood Investigation
Client	Wimmera CMA
Client Project Manager	Paul Fennell
Water Technology Project Manager	Ben Hughes
Report Authors	Ben Hughes
Job Number	2120-01
Report Number	R06v02
Document Name	2120-01R06v03.doc

Following the December 2010 and January 2011 flood events, Water Technology was commissioned by the Wimmera CMA to undertake the Natimuk Flood Investigation. This included detailed hydrological and hydraulic modelling of Natimuk Creek and Little Natimuk Creek, flood mapping of the Natimuk township area, flood mapping of the entire upstream catchment, and also provided recommendations for flood mitigation works.

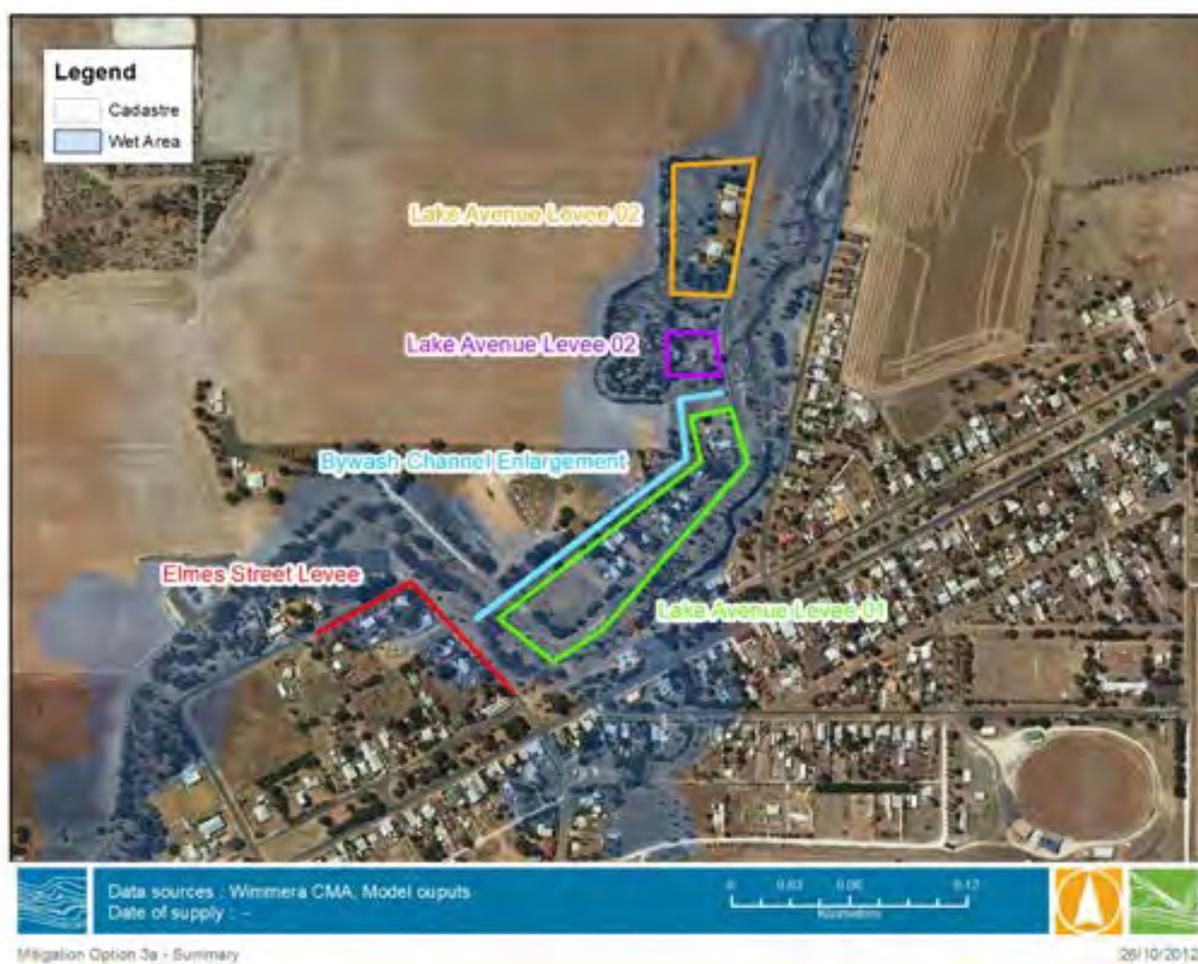
Figure 10-1 Combined option 03a

Combined Option 03 involved the construction of three levees. Lake Avenue Levee 02 protected one house, while Lake Avenue Levee 03 protected two houses. As these levees are likely to be uneconomical to build for the number of houses they protect, flood damages were calculated with and without their inclusion. Combined Option 03a included the levees protecting the properties and Combined Option 03b raised the floor level of one property. This property was protected by the second Lake Avenue levee. Properties protected by the third Lake Avenue Levee, although impacted below floor, have a floor level at more than the 300mm above the 100 year ARI water level. Combined Option 03b used the existing conditions damages for an assessment of external damages but without above floor building damages.

Figure 10-1 and Figure 10-2 show the location of the levees and impacted flood levels for Combined Option 3a and 3b respectively.
