## **Dirt Jumps – Management Plan**

A Dirt Jumps Management Plan has been developed to guide the safe operation and maintenance of the dirt jumps and to protect the environmental values and public amenity at both the Burnt Creek and Park Drive sites.

**CULTURAL HERITAGE MANAGEMENT PLAN 20945**

# **BURNT CREEK BIKE JUMPS**

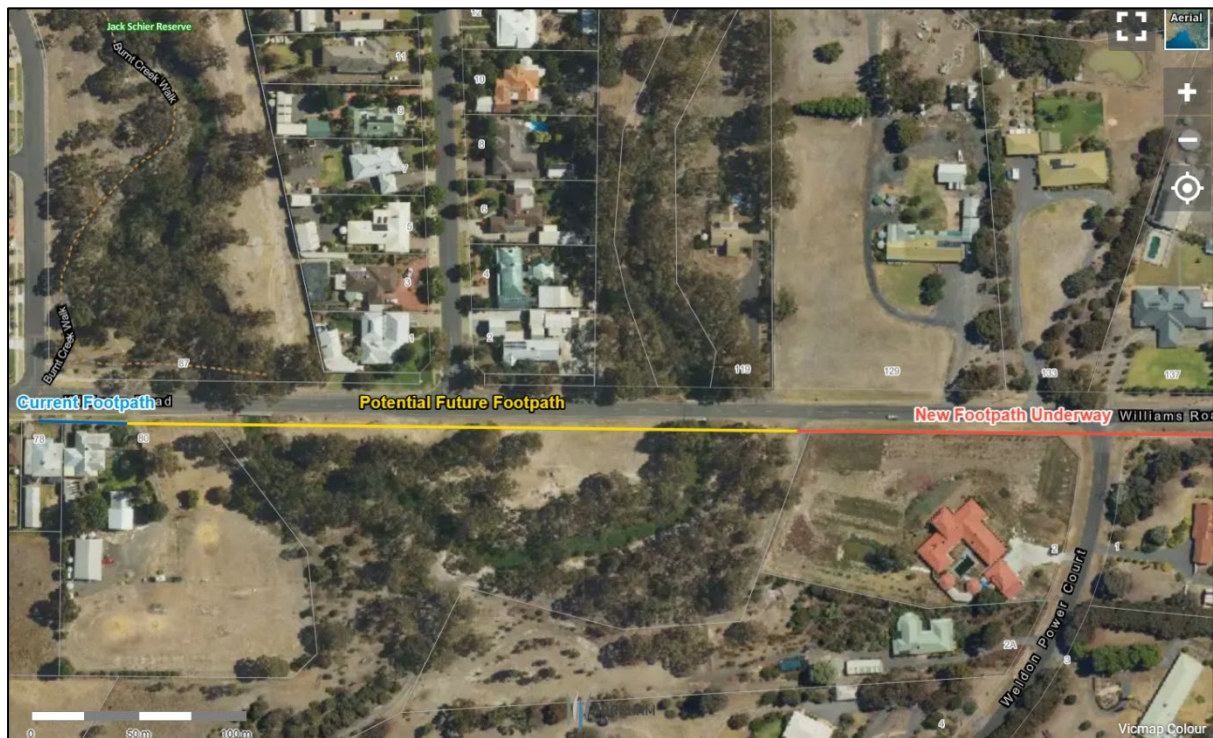
Figure 2 Location of future footpath (Source: Dale Schmid, 4 December 2025)

The proposed activities involve the formalisation of the existing bike jumps along Burnt Creek and the construction of a footpath approximately 4m south of Williams Road connecting existing paths. Currently, there are no plans to create new bike jumps; however, future work at the site may involve the creation of new jumps using heavy machinery, or the levelling of existing jumps that have been deemed to be unsafe. Seating will also be installed at the site positioned on an above ground concrete slab. The construction of a 1.5m footpath will involve excavation to approximately 100-200mm and the placement of gravel to create a formed path (see Figure 2).

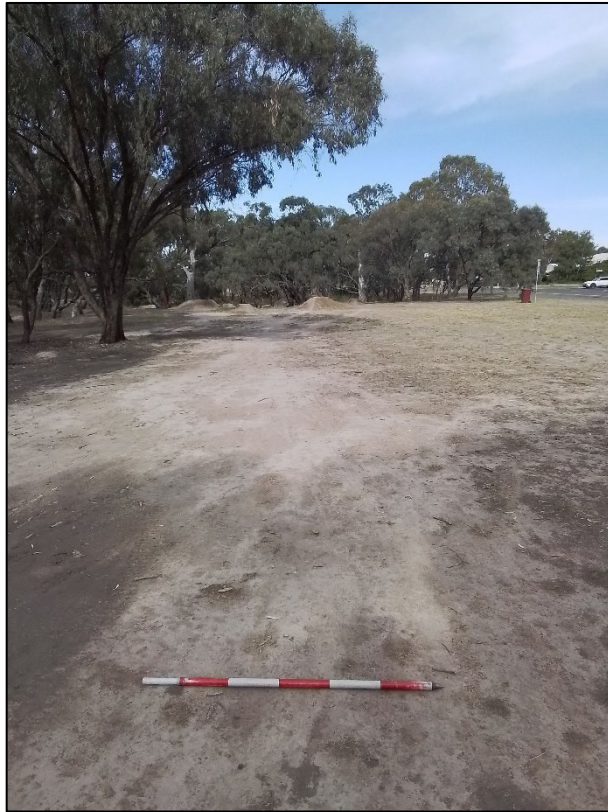
**Photograph 9 Looking west across Activity Area towards eroded track and bike jumps, 12 December 2025**

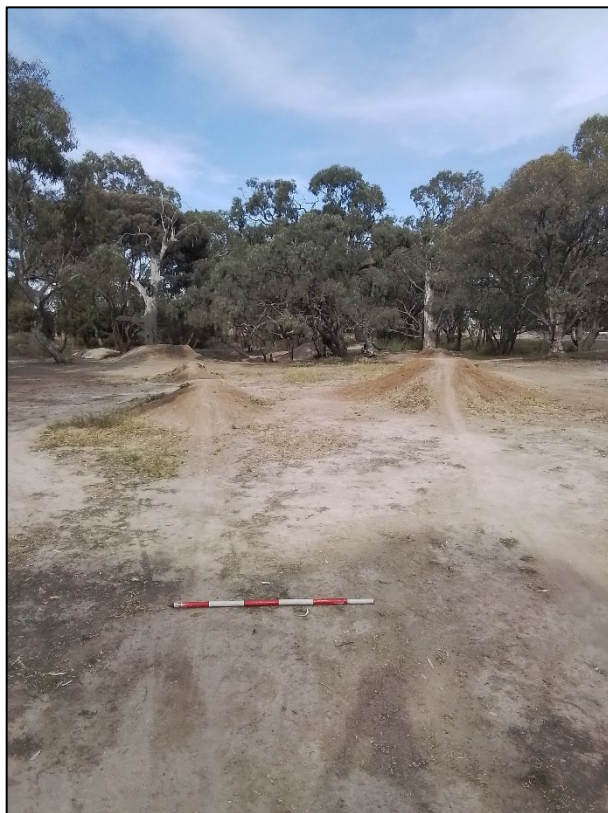
**Photograph 10 Looking west across Activity Area showing erosion and bike jumps, 12 December 2025**

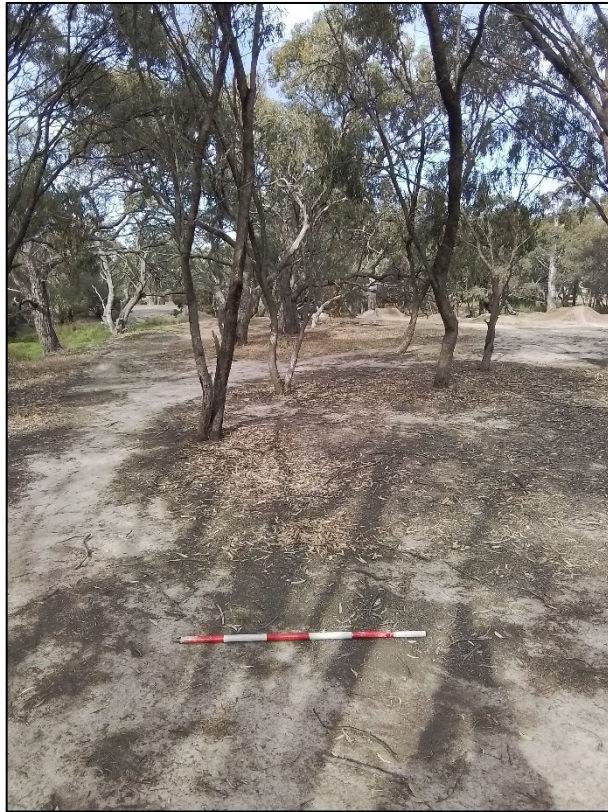
**Photograph 11 Looking west across eroded bike track, 12 December 2025**

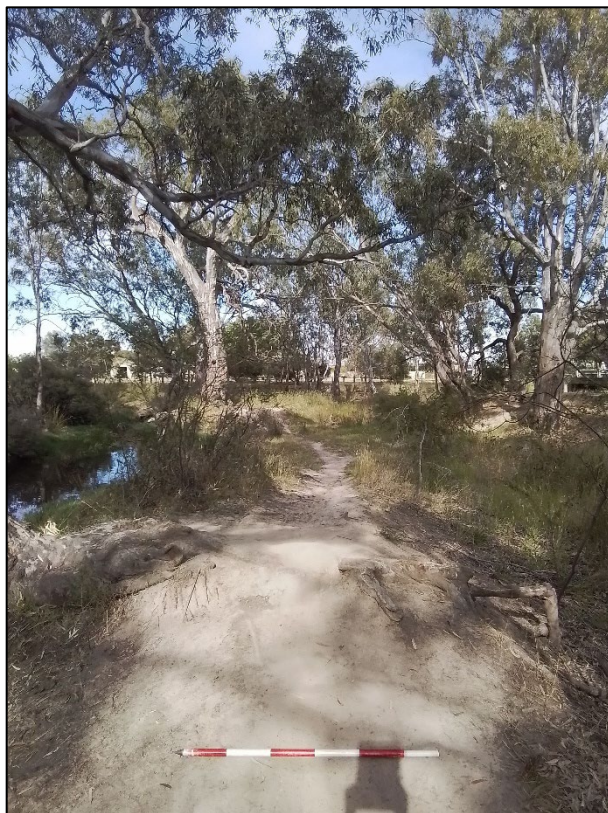
**Photograph 12 Looking west along eroded bikh path on edge of Burnt Creek, 12 December2025**

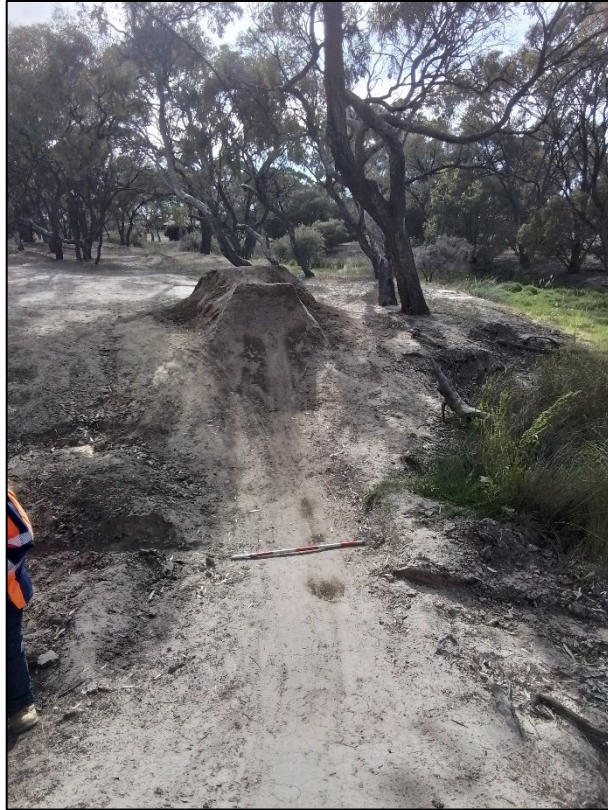
**Photograph 13 Looking east across eroded bike track in gully and jumps, 12 December 2025**

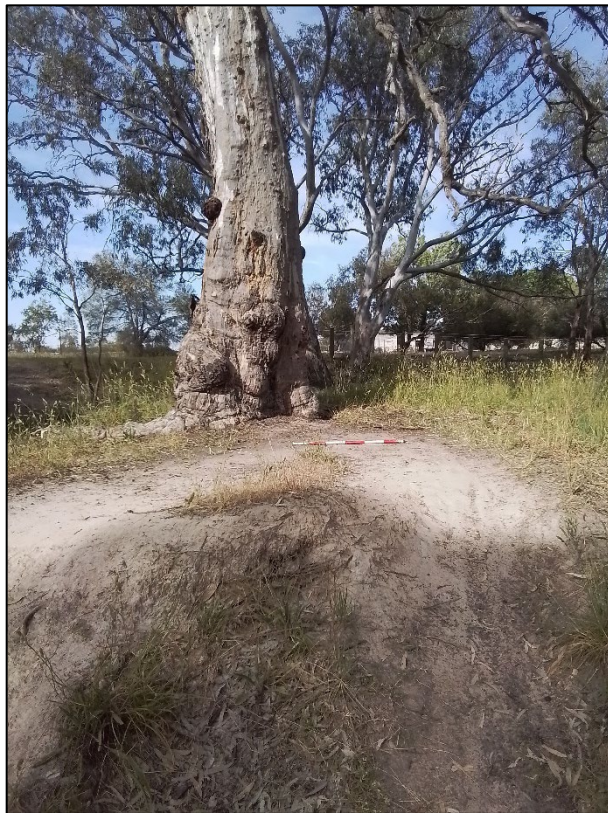
**Photograph 14 Looking south-west across eroded turn around point along bike track, 12 December 2025**

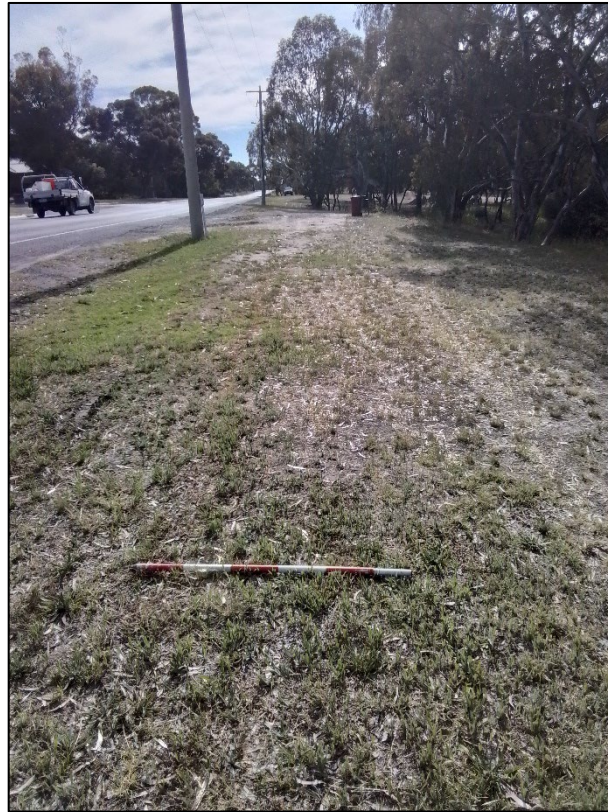
**Photograph 15 Looking east across proposed location for new footpath adjacent to Williams Road,  
12 December 2025**
