Warracknabeal and Brim Flood Investigation - Flood Intelligence Report

September 2016

Project Name	Warracknabeal and Brim – Flood Intelligence Report
Client	Wimmera CMA
Client Project Manager	Clare Wilson
Water Technology Project Manager	Ben Hughes
Report Authors	Ben Hughes
Job Number	3532-01
Report Number	R03
Document Name	3532-01R03v02_Flood_Intel.docx

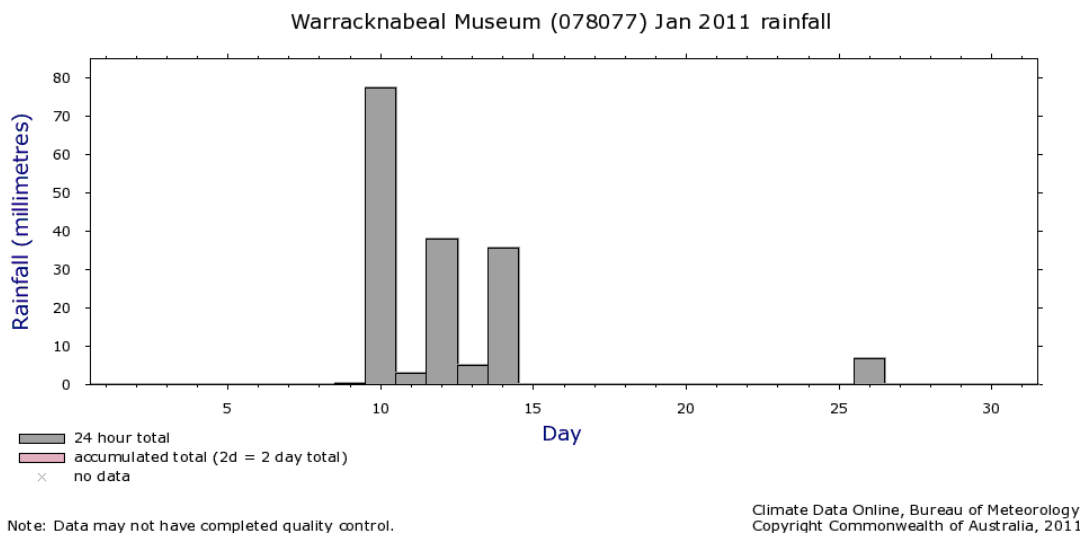
Figure 1-2 Warracknabeal Museum daily rainfall records (1st – 31st January 2011)²

High rainfall totals were recorded across the Wimmera River and Yarriambiack Creek catchments between the 9th and the 15th of January 2011. The Warracknabeal Museum daily rainfall gauge recorded rainfall totals of 77, 38 and 36 mm on Monday the 10th, Wednesday the 12th and Friday the 14th of January respectively, as shown in Figure 1-2.

Direct runoff caused localised flooding in and around Warracknabeal and Brim after the initial rainfall. The Warracknabeal daily rainfall record for January 2011 is shown in Figure 1-2.

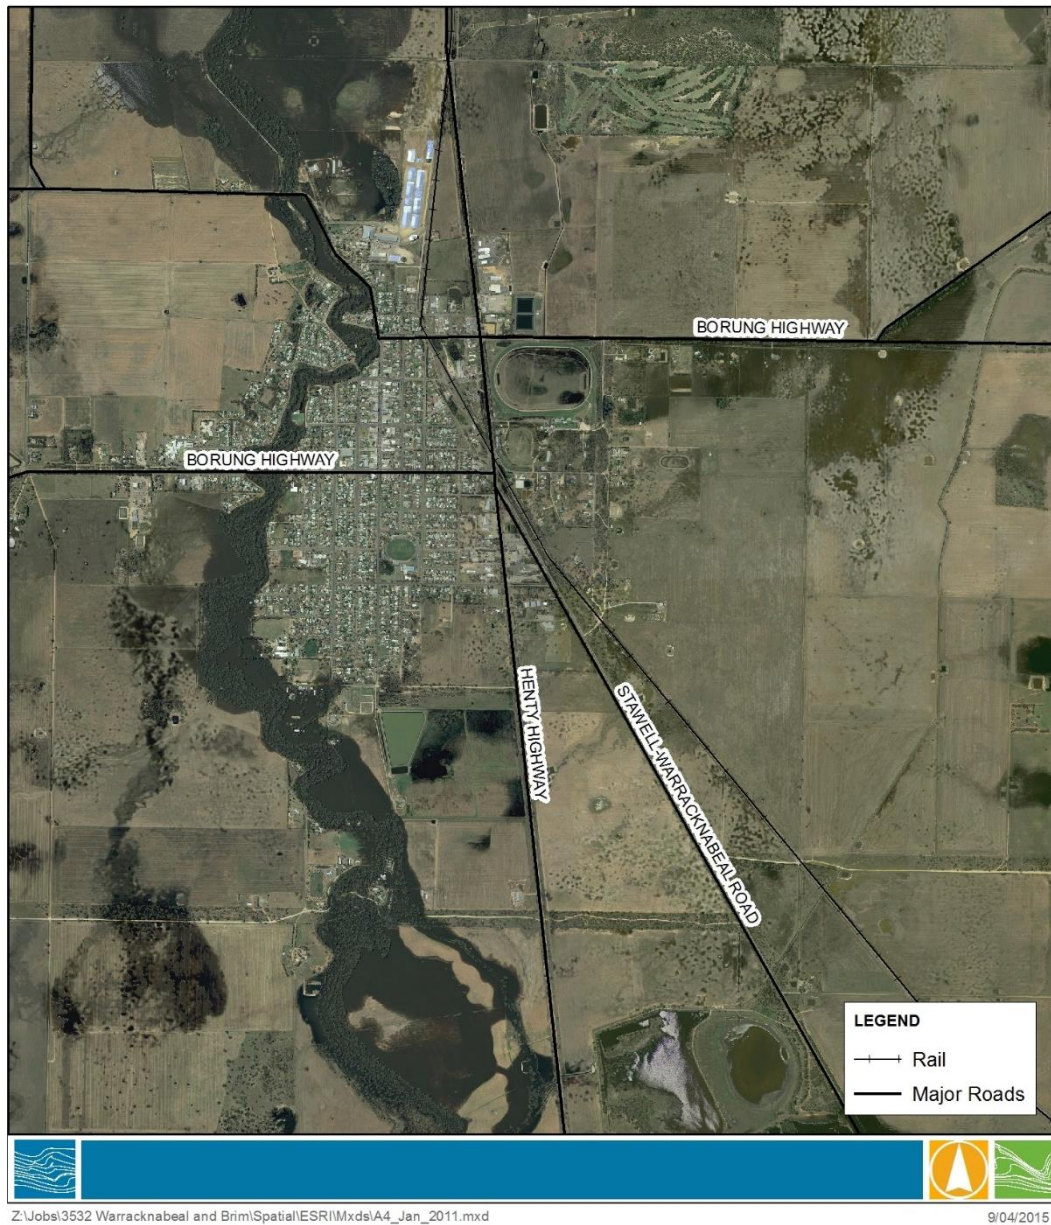
Figure 1-3 Warracknabeal – January 2011 stormwater inundation

The stormwater inundation observed in Warracknabeal during January 2011 is shown in Figure 1-3 with flood inundation in Warracknabeal on the 20th January 2011 shown in Figure 1-4 and inundation in Brim occurring on the 21st of January shown in Figure 1-5.

Warracknabeal suffered from stormwater inundation in several locations across town during January 2011, these included:

- Borung Highway
- Gardiner Street
- McIntyre Street
- Asquith Reserve

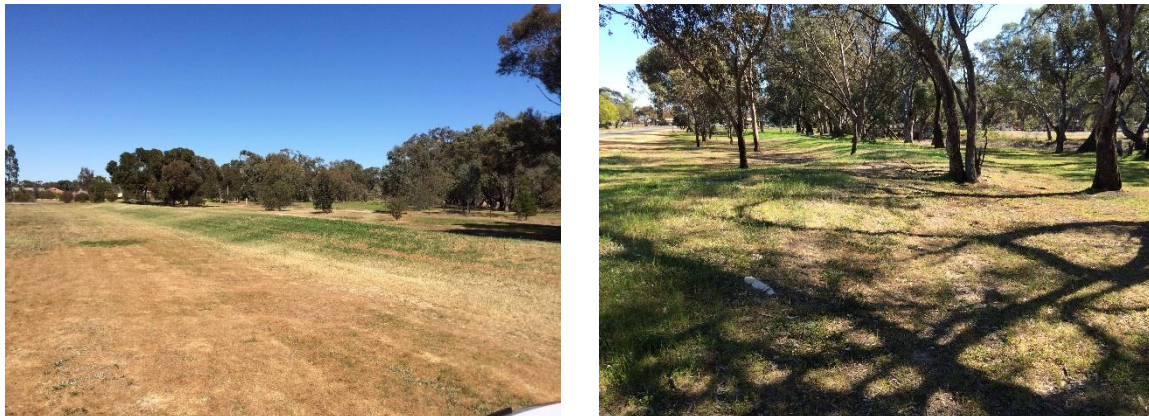
Figure 1-10 Remnant sections of levee (Water Technology)

During January 2011 a very comprehensive levee system was constructed protecting Warracknabeal, with several of these remaining. These levees were formalised by Yarriambiack Shire Council. The location of the remnant levees is shown in Figure 1-11, the levees have been constructed into grassed earthen mounds or walking tracks as shown in Figure 1-10³.

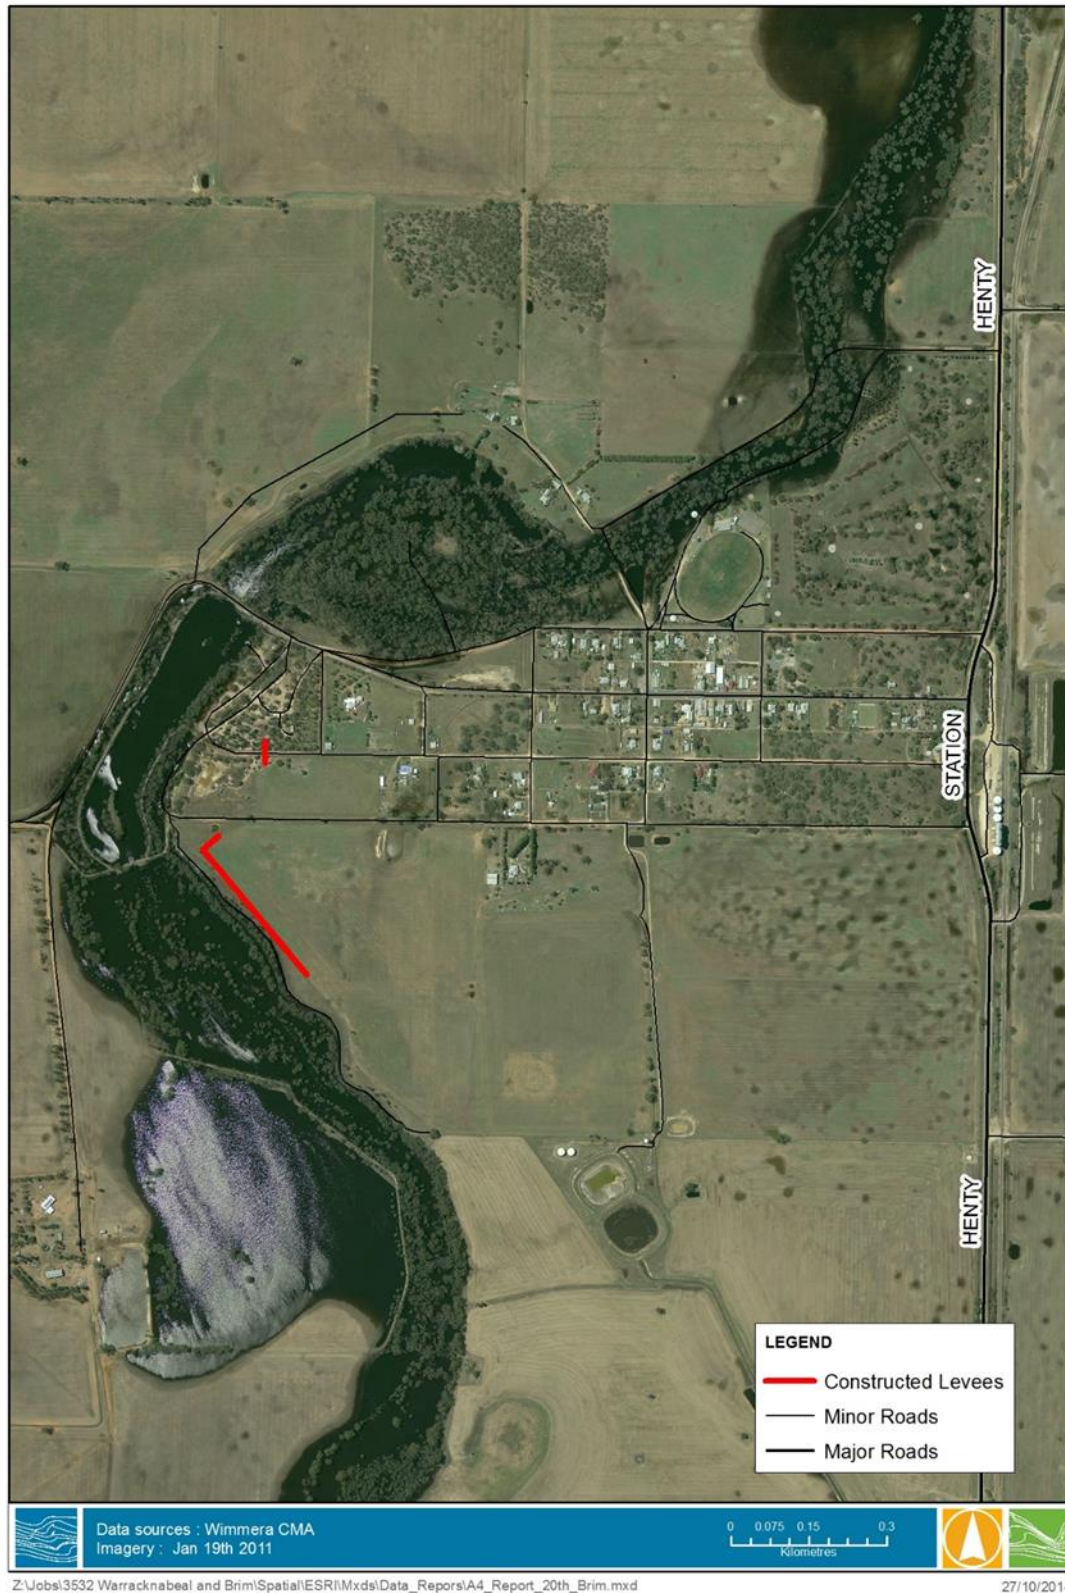
Figure 1-12 Brim Remnant Levees (not required up to a 0.5% AEP event)

Levees in Brim were also constructed during January 2011, however these levees were not required during January 2011 and modelling undertaken during the Warracknabeal and Brim Flood Investigation³ has shown they are unnecessary up to a 0.5% AEP event. The levees remained in place at the time of this reports production and are shown in Figure 1-12.

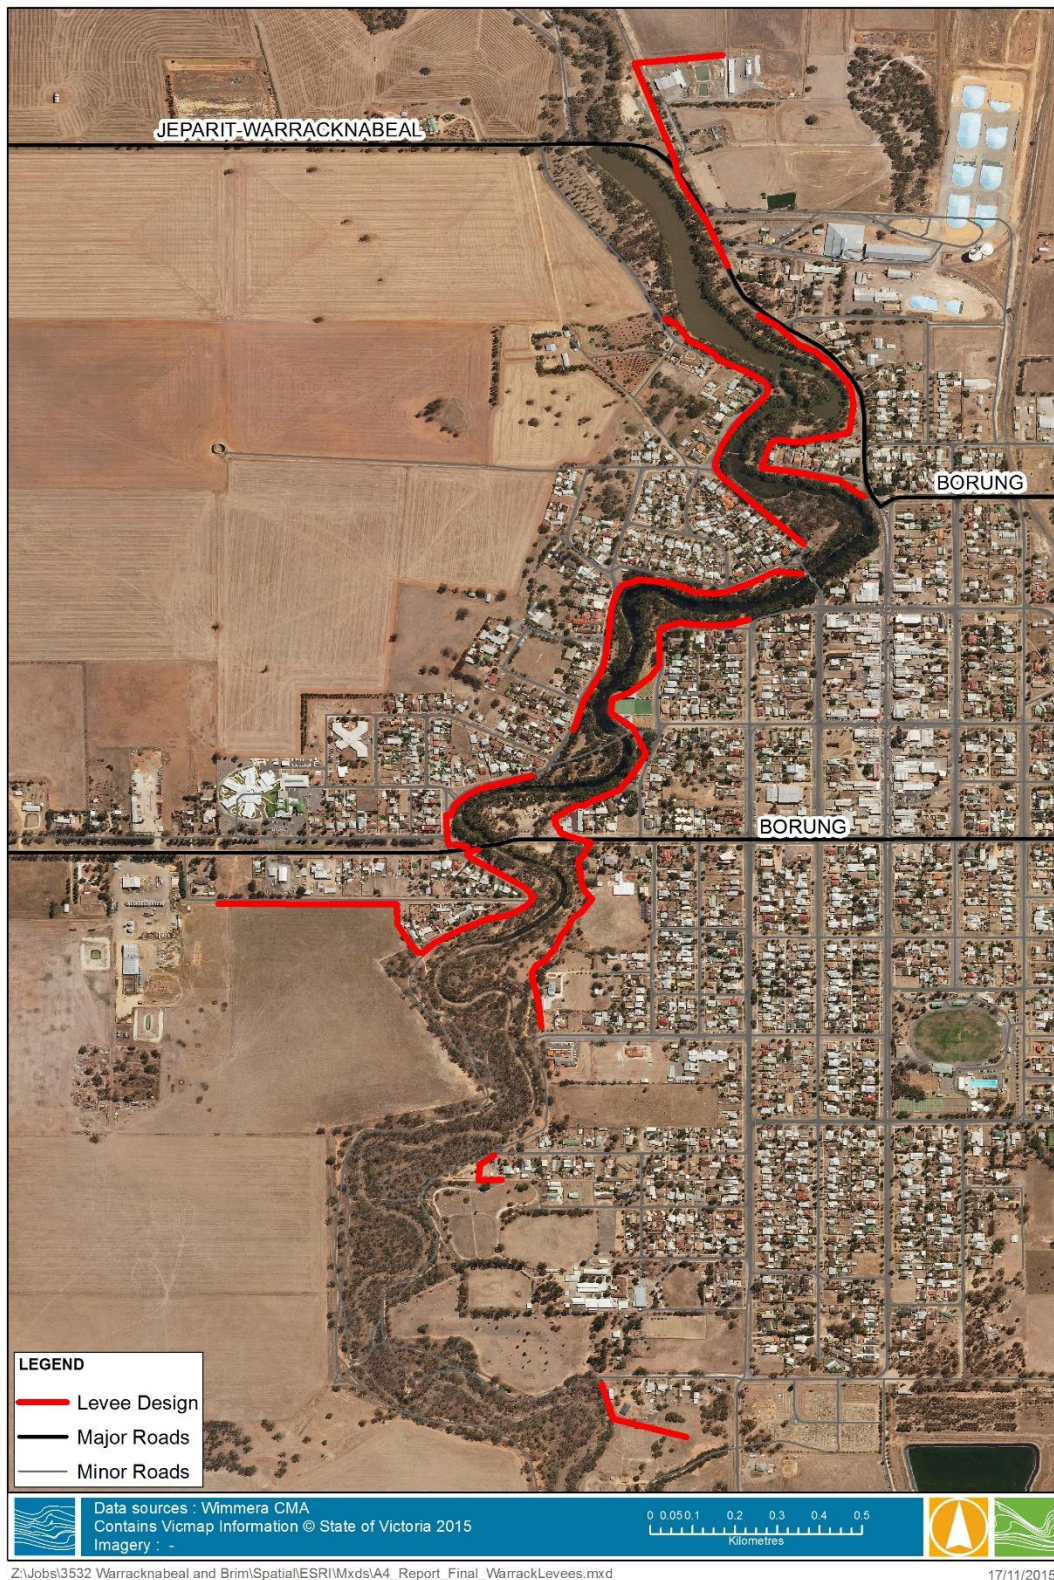
Figure 1-13 Warracknabeal design levee alignment

The Warracknabeal and Brim Flood Investigation³ determined an optimised levee design based on the levees constructed during January 2011 and the modelling results. The levee was designed to the 1% AEP design flood height with a 100 mm freeboard in permanent sections with temporary sections protecting to the 0.5% AEP event. At the time of this reports production the design levees had not

been constructed and were not guaranteed funding. The design levee alignment is shown in Figure 1-13 and was shown to protect 54 buildings from above flood inundation in Warracknabeal in a 0.5% AEP event with one remaining inundated. No buildings were shown as flooded worse as a result of the levee.

The Warracknabeal and Brim Flood Investigation also completed detailed designs for new and upgraded existing levees in Warracknabeal, these levees protect all but one property in Warracknabeal from below and above floor inundation without adversely impacting other residents. This property is the Rusty Nail and requires site specific protection.
