HERITAGE CITATION REPORT

name: Behlen Grain Silo
Address: 44 Noradjuha - Toosan East Road NORADJUHA
Place Type: Silo
Citation Date: 2022

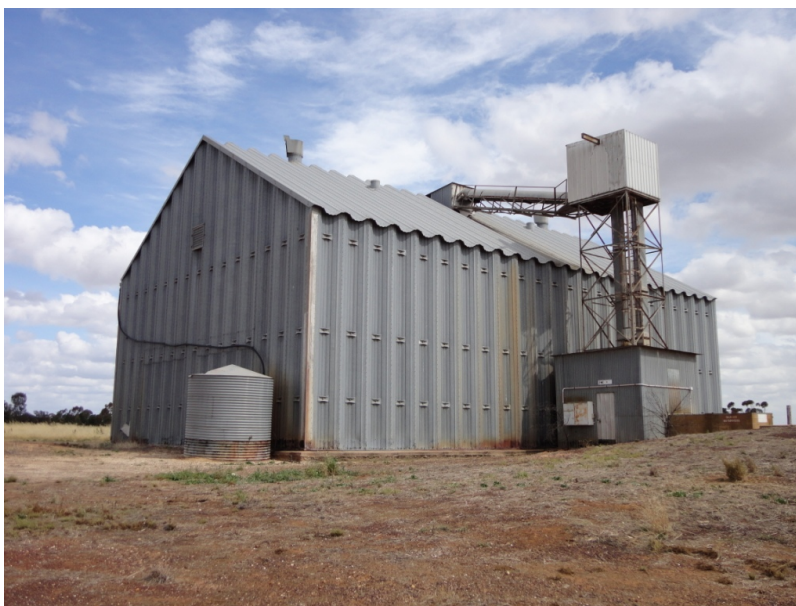
High – in original condition and unaltered intact when compared with 1961 construction photograph. Appears to be most intact and highest integrity example in Victoria.

67x 20 metre shed – unique ‘folded galvanised steel sheet’ self-supporting construction for roof and walls, negating the need for structural steel framing for the shed. Shed has a gable roof of 20-25 degree pitch. Shed is a ‘BEHLEN’ shed, manufactured in USA and exported to Victoria. Grain Elevators Board purchased seven sheds – Noradjuha shed is one of the sheds purchased. In 2014 it was still utilised as grain storage shed, but this had ceased by 2022. Construction comprises galvanised steel pan sections, folded off site to provide stiffness for structural support. Shed held together via steel rods, fixed across structure and supported on galvanised steel brace plates externally. Grain fed to top via truck dump bins (pit) to side and fed to top. Grain access doors and personal access doors at base. Shed sits to side of former rail siding.

Average to good condition – surface corrosion (viewed from exterior) minimal. All parts of shed still extant and shed has not been noticeably modified from original installation.
