HERITAGE CITATION REPORT

name: Thatched Barn
Address: 1665 Obrees Road VECTIS
Place Type: Barn
Citation Date: 2022

Thatched Barn

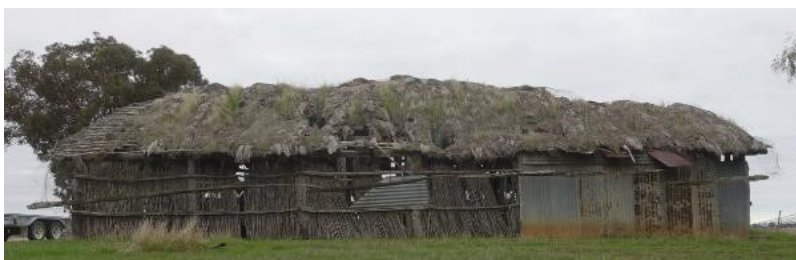
The original cladding of the south end wall has been replaced with corrugated steel sheets.

Fair condition. Roof and walls largely intact, despite some collapse of thatching and loss of gable end wall cladding.
