HERITAGE CITATION REPORT

Name: Former Natimuk State School No. 1548

Address: 1a Sudholz Street, Natimuk

Citation date: September 2023

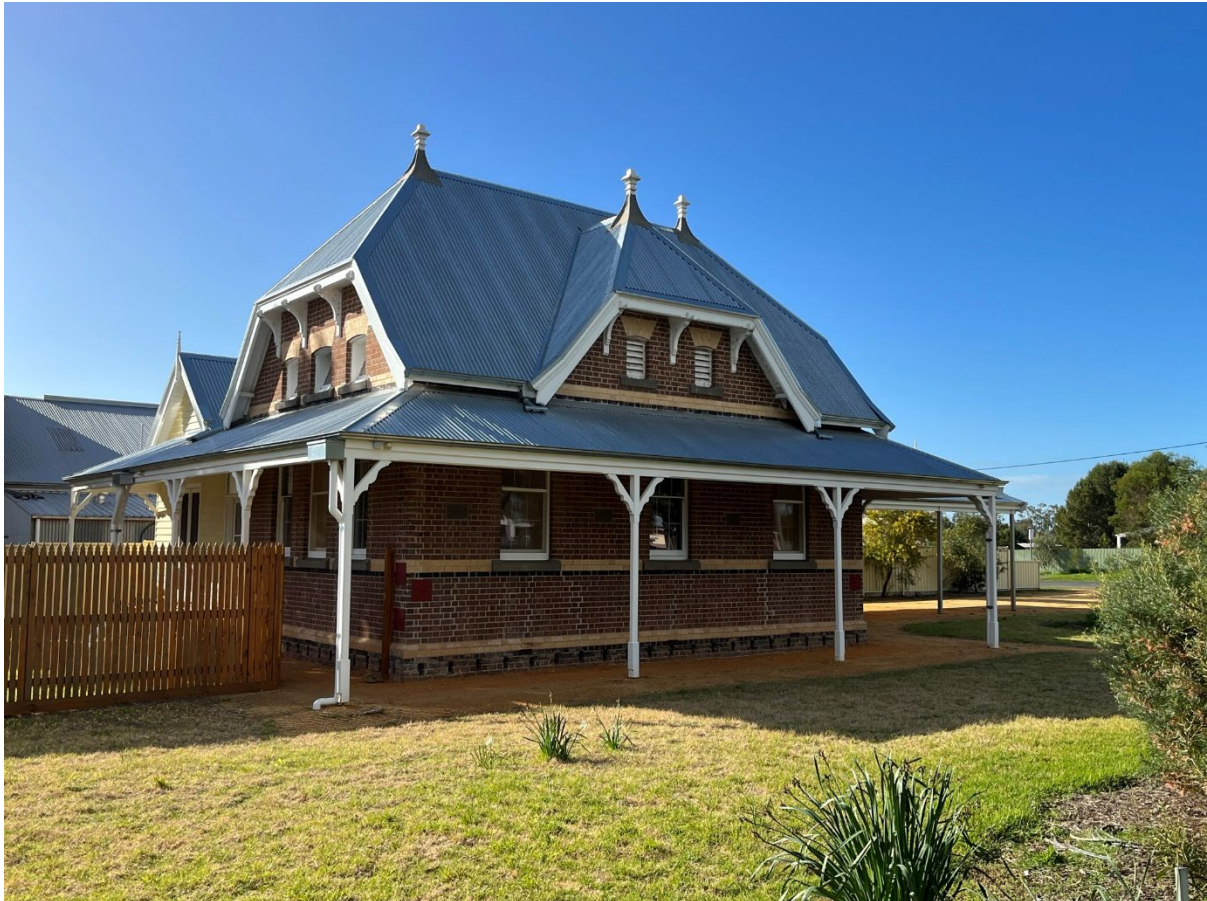
Former Natimuk State School, 1a Sudholz Street, Natimuk, viewed from Main Street (GGA, September 2023)

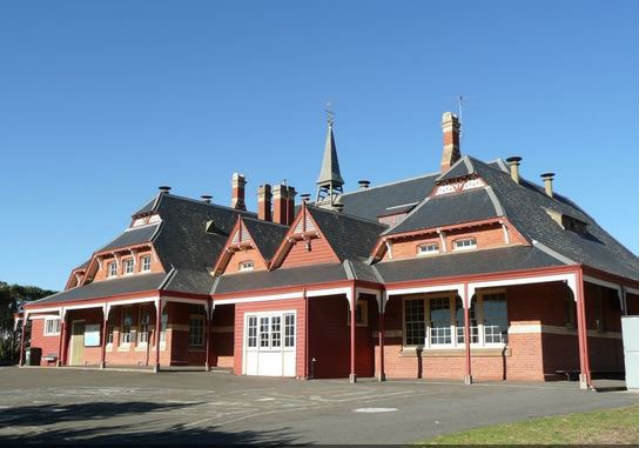
Place	Description	Image
<p>Avoca State School No. 4 (1878) VHR</p>	<p>Avoca Primary School is of architectural significance as a precedent for a number of subsequent school buildings in Victoria. The Avoca School is a single storey, asymmetrical, red brick building with simple cream brick banding and a high pitched, tent-like slate roof. The building is encircled by verandahs.</p> <p>The Avoca Schools is regarded as the most intact of the Horsham – Avoca model.</p>

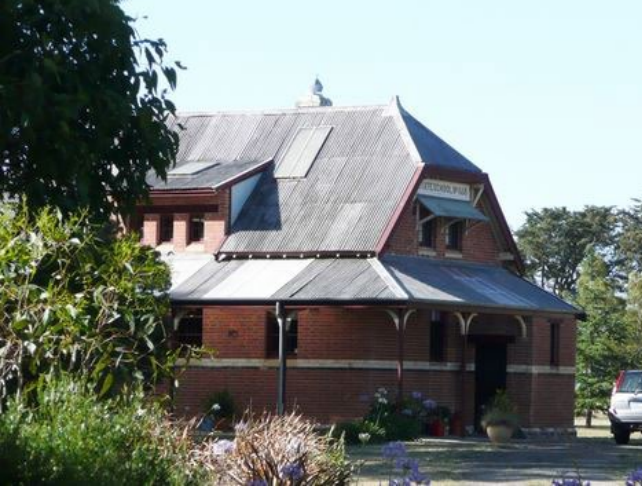
<p>Former Primary School No. 668, Western Highway, Cardigan (1883) (456 Remembrance Drive Windermere, Ballarat City) VHR</p>	<p>A brick school opened in 1883, as the Windermere Town School, to replace an earlier wooden building of 1860. The structure was designed by the Public Works Department of Victoria. The roof is essentially hipped in form, with jerkinhead roof, bracketed gables allowing top-lights. A timber verandah faces three sides and there is a tall brick chimney.</p> <p>This example is of a similar scale to the Natimuk School.</p>
