HERITAGE CITATION REPORT

name: Former St Johns Catholic Church
Address: 27-29 Main Street NATIMUK
Place Type: Church,Residence
Citation Date: 2022

St Johns Catholic Church, 27-29 Main Street Natimuk

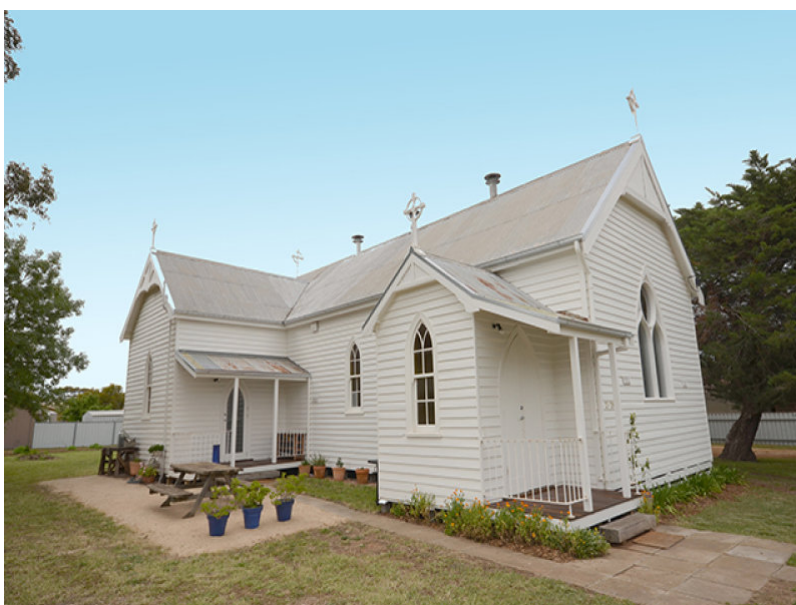
Excellent (restored) condition and all early fabric of church extant. Pews and liturgical furniture no longer extant.

Timber framed and timber weatherboard clad church, with CGI clad gable roof and stumped floor. Entry porch and vestry also gable roofed. Finials of note – featuring decorative crosses. Church features lancet double hung windows, with decorative timber glazing bars. Front window has trefoil glazing, with a rose window at the top. Church features two porches. Interior features a coved ceiling lined with beaded boards and exposed metal tie rods. Altar has a raised floor, with the chancel wall lined with decorative pressed metal panelling. Decorative pressed metal panelling with gothic arch motifs also features as wainscoting around the nave.

Good condition – recently renovated. Contemporary bathroom and kitchen in vestry. Original church furniture and vestments no longer extant.
