6. Flood Intelligence Card, Property Inundation List and Flood / No Flood Guidance Tool

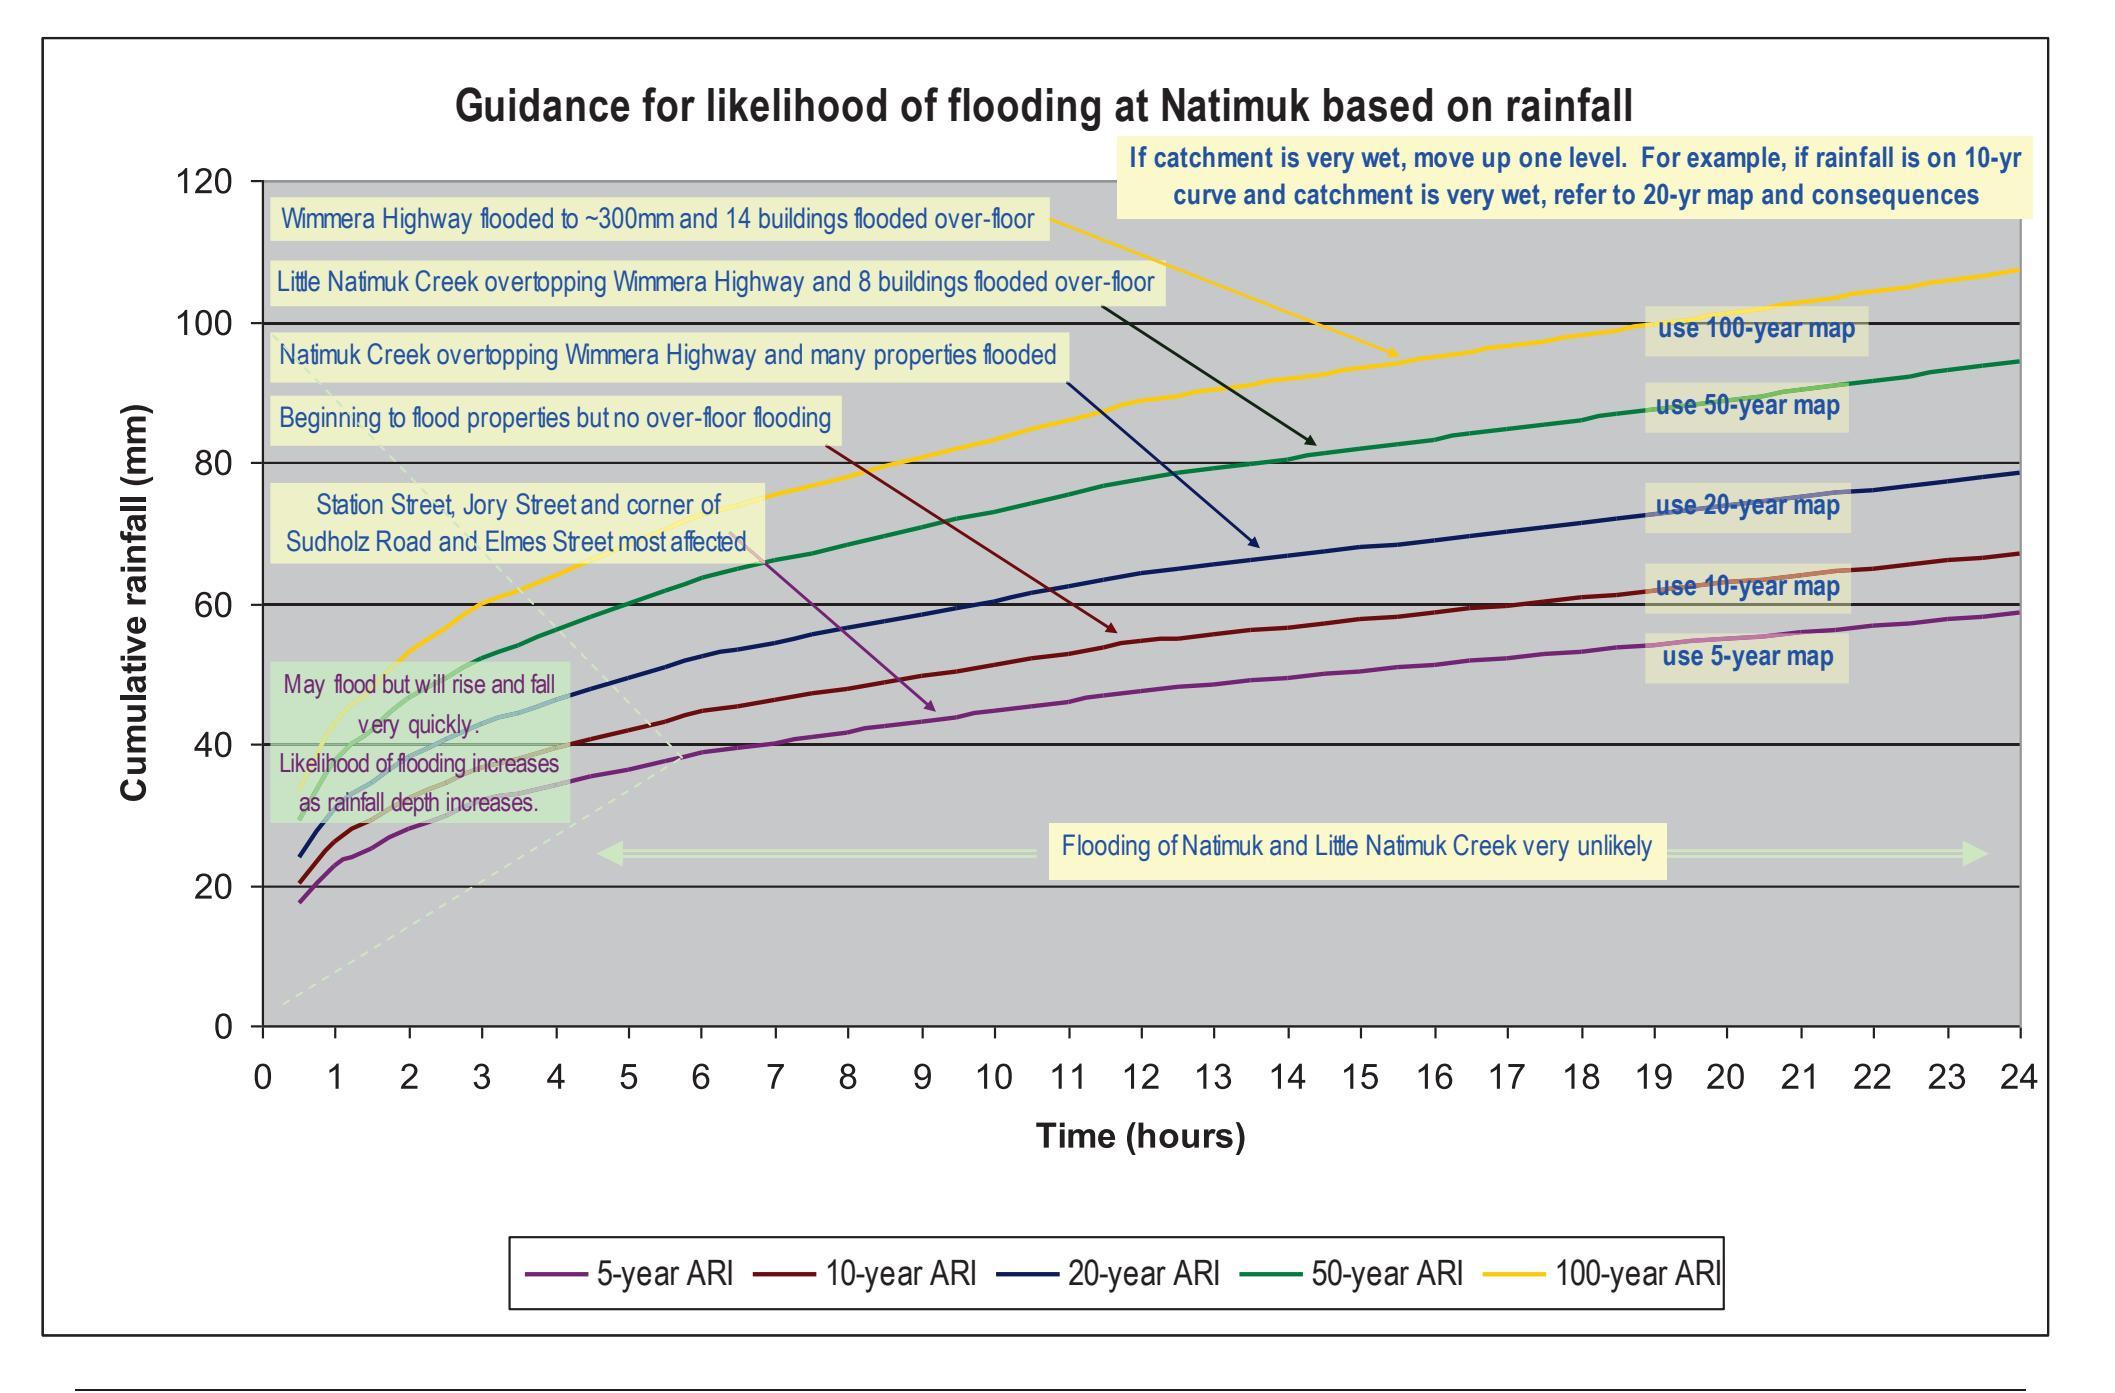
Approach 1: Using the total rainfall depth obtained (from an AWS or alternative source) from the start of the event (discount early drizzle or very light rain), plot the rainfall depth against elapsed time on a copy of the tool. Assess the likelihood and expected severity of flooding from the curves with due regard for included notes.

Approach 2: Discount the early lighter rain from consideration (i.e. begin calculating rainfall depth from start of heavy rain) and plot depth against time on a copy of the tool. Assess the likelihood and expected severity of flooding from the curves with due regard for included notes.

A word of caution. The tool does not enable accurate predictions of peak gauge heights or time of peaks to be made but does give indicative guidance as to the expected severity of flooding and thus likely consequences. However, it must be remembered that the tool provides indicative, not exact, guidance and must be used with some thought as well as knowledge of local conditions.

It is suggested that data from the Horsham Aerodrome AWS, Longerenong AWS and Polkemmet Road (Horsham) (see BoM website) or alternative closer locations is used to determine an appropriate rainfall depth for use in the following indicative Flood / No Flood guidance tool. It is further suggested that either an average value is used to drive the tool or, for a more conservative approach, the maximum depth from these gauges. This approach will work reasonably well as the rainfall gradient across the Municipality is minimal.

Two approaches can be used during a rainfall event to determine the likelihood and expected severity of flooding. Both approaches can be used simultaneously using the same copy of the tool. Unless there are unusual circumstances, actions as per the Flood Intelligence Card should be initiated as soon as the tool suggests flooding is likely. Response can be escalated if the tool indicates an increase in the expected severity of flooding.

After a flood event, plot the event rainfall depth with a date on the tool and include an overview of the event, including antecedent conditions, in Appendix A of this MFEP.
