HERITAGE CITATION REPORT

name: Vectis Zion Lutheran Church
Address: 121 Vectis Station Road QUANTONG
Place Type: Church
Citation Date: 2022

Vectis Lutheran Church

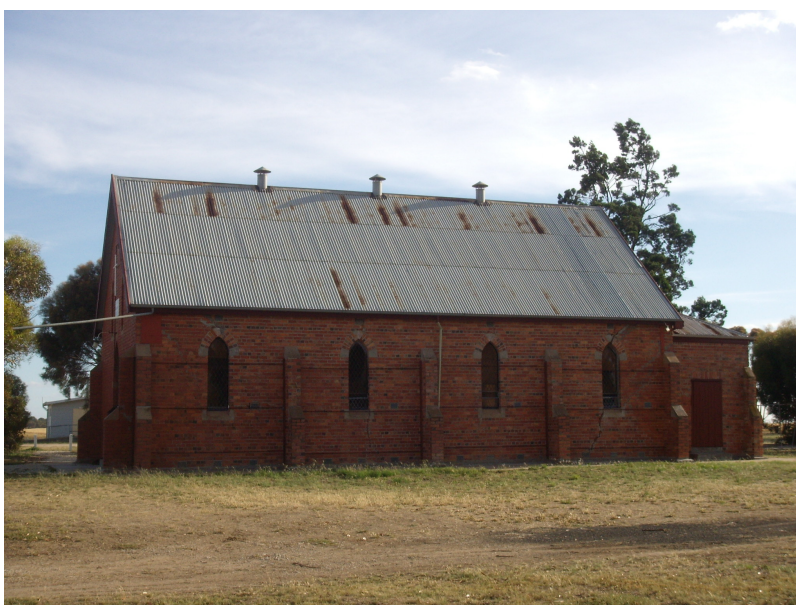
External condition – sound. Much of the rear part of the Church has been repointed. Church as stands illustrates function within community.

Simple Gothic Revival chapel form church, with a steep gable roof form, face red brick walls, brick buttresses, pointed arch head windows with leaded/ coloured glass and hipped roof vestry to rear. Some glass has been replaced (due to the 2013 damage to the place). Window sills and heads are dressed with cement stucco. Face bricks are most probably local in origin – similar in colour/ texture to several buildings of similar era in the Vectis/ Natimuk locale. It is tuckpointed to the front façade. Windows incorporate a fixed open hopper section for ventilation and are detailed with diamond lead bars, with coloured glass surrounds. The roof ridge is finished with three capped roof vents. A painted sign on the front façade reads in German: 'Ev = Luth Zions = Kirche'.

The 1907 Church is in fair condition – given the reactive nature of local soils. Wall cracking is evident to all facades, typically from eave to window head and then sill to footing – cracks are in the order of 2-10mm wide. Steel tie rods and rail lines have been fitted to the building at some time. Several leaded glass windows have become dislodged within openings, with flashings compromised as a result. Glazing remains intact, apart from one rear window. Perimeter of building is paved, assisting in limiting structural movement and any rising damp issues. Timber entry doors and rear doors are simple in profile and are in average condition.
